Airworthiness Directive

Docket No. 96-CE-09-AD; Amendment 39-10864; AD 97-01-01 R1

Airworthiness Directives; The New Piper Aircraft, Inc. PA-24, PA-28R, PA-30, PA-32R, PA-34, and PA-39 Series Airplanes

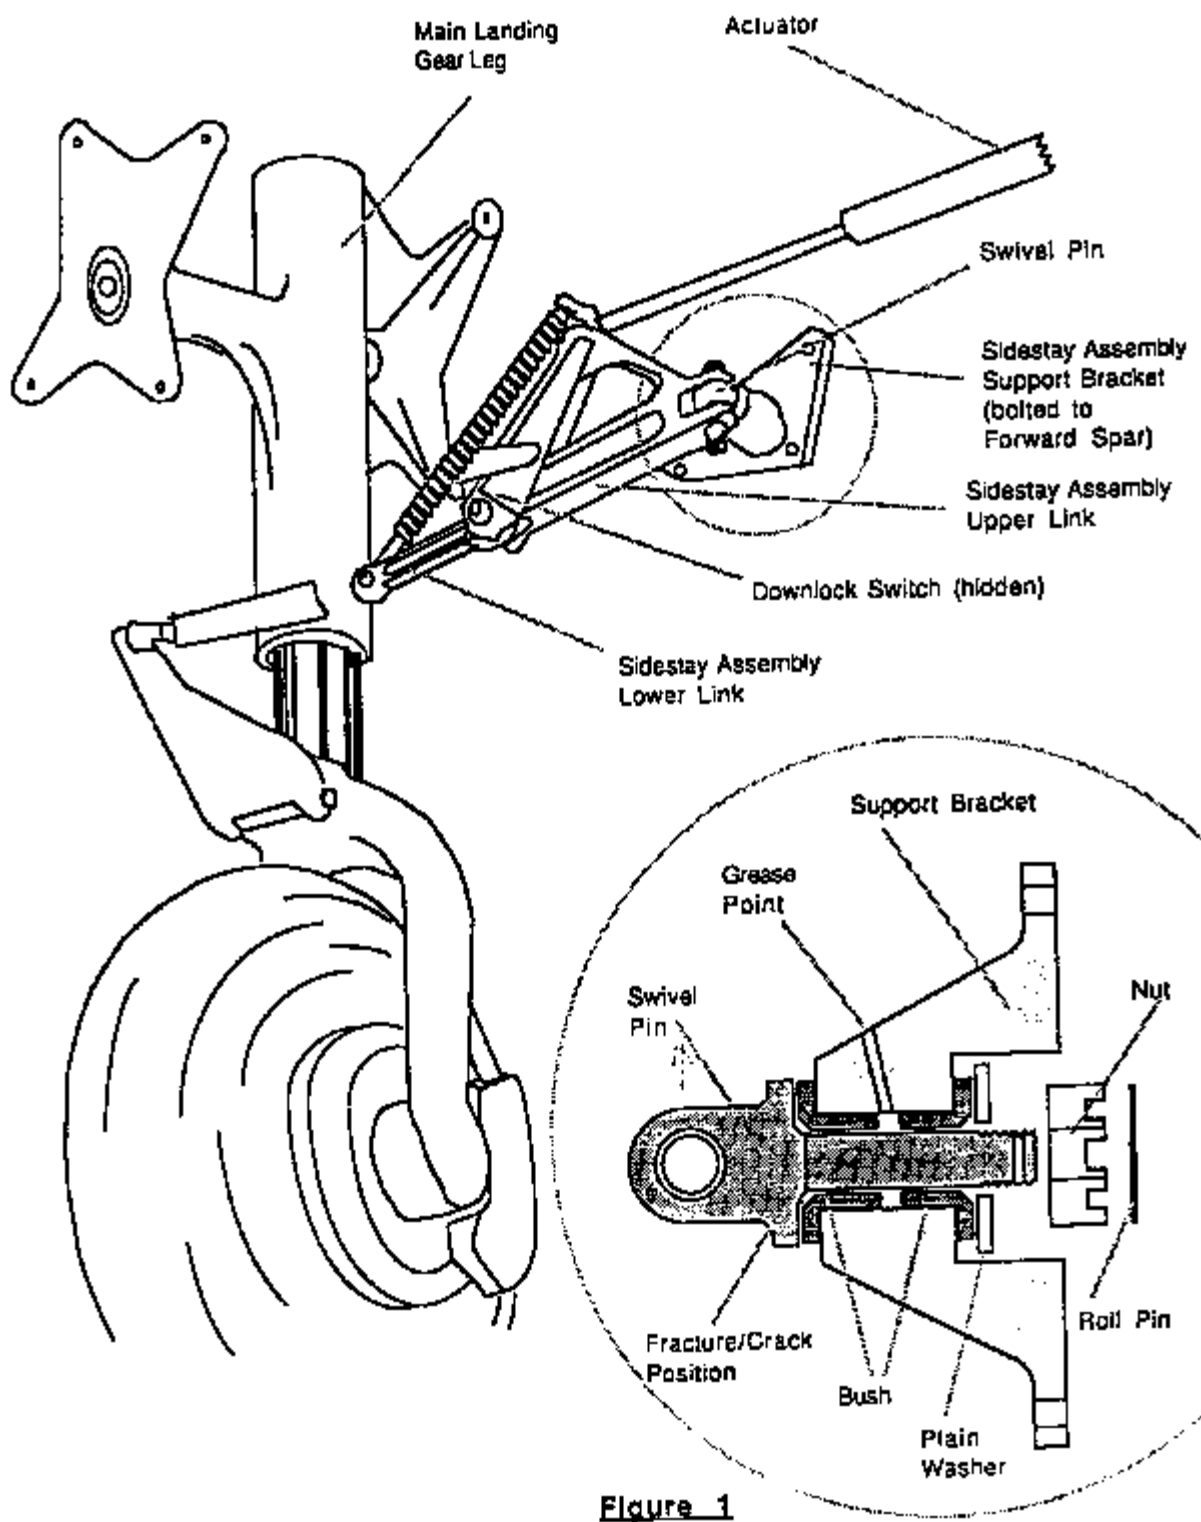
Figure 1
AD 97-01-01

(a) Remove both the left and right main gear sidebrace studs from the airplane in accordance with the instructions contained in the Landing Gear section of the maintenance manual, and inspect each main gear sidebrace stud for cracks, using Type I (fluorescent) liquid penetrant or magnetic particle inspection methods. Figure 1 of this AD depicts the area of the sidebrace stud shank where the sidebrace stud is to be inspected.

(1) For any main gear sidebrace stud found cracked, prior to further flight, replace the cracked stud with an FAA-approved serviceable part (part numbers referenced in the table in paragraph (b) of this AD or FAA-approved equivalent part number) in accordance with the instructions contained in the Landing Gear section of the applicable maintenance manual, and accomplish one of the following, as applicable:
