CRITICAL SERVICE BULLETIN

CATEGORY 2**CSB19-01A**

**Supersedes CSB19-01
TECHNICAL PORTIONS
FAA APPROVED**

SUBJECT: Fuel (Primer) Diverter Valve Assembly**PURPOSE:** To assist Owners, Operators, and Maintenance Facilities with instructions to remove the fuel diverter valve assembly and provide available options to the fuel injection system for continued service.**COMPLIANCE:** Within the next 25 hours of engine operation or the next scheduled inspection or engine servicing, whichever occurs first.**MODELS****AFFECTED:** New and rebuilt Continental Aerospace Technologies IO-360-ES; LTSIO-360-E, EB & KB; TSIO-360-E, EB, F, FB, G, GB, KB, LB, MB & SB; TSIO-520-BE and TSIO-550-A, B, C & E aviation gasoline (AvGas) engines.**I. GENERAL INFORMATION**

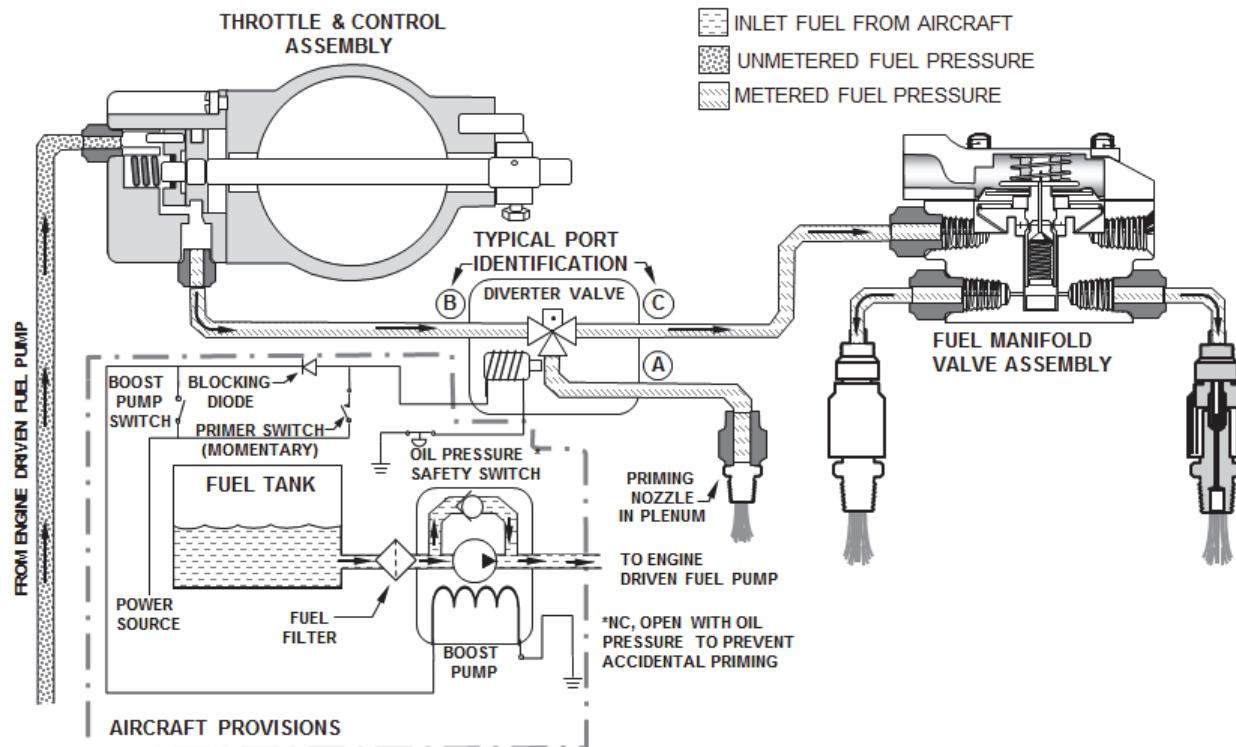
Figure 1. Fuel Diverter Valve Assembly, typical

Continental Aerospace Technologies™ (Continental®) has received reports of fuel (primer) diverter valve malfunction that can result in a partial or complete loss of power.

- Verify your cross-flow engine has a fuel diverter valve assembly (P/N 633862, 642199 (14V), 633862-2, or 649268 (28V as shown in Figure 1).

- Remove the fuel diverter valve assembly from service according to the latest revision of the applicable Maintenance and Overhaul Manual, Section 12 (engines as listed in the "Models Affected").

- Remove fuel diverter valve assembly (tubes and connectors) between the throttle and control assembly and fuel manifold valve assembly (see Figure 1, port identification B & C and Figure 2 through Figure 4, example configurations).
- Remove tube/hose assembly, as applicable, (see Figure 1, port identification A and Figure 2) between fuel diverter valve assembly and priming nozzle(s).
- Remove disconnected priming nozzle connector(s) and tube assemblies connected to induction system (location references see Figure 2 and Figure 8).
