SERVICE No. 1122 BULLETIN

Date: March 7, 2003 (S)

SUBJECT: WING RIB INSPECTION(S)

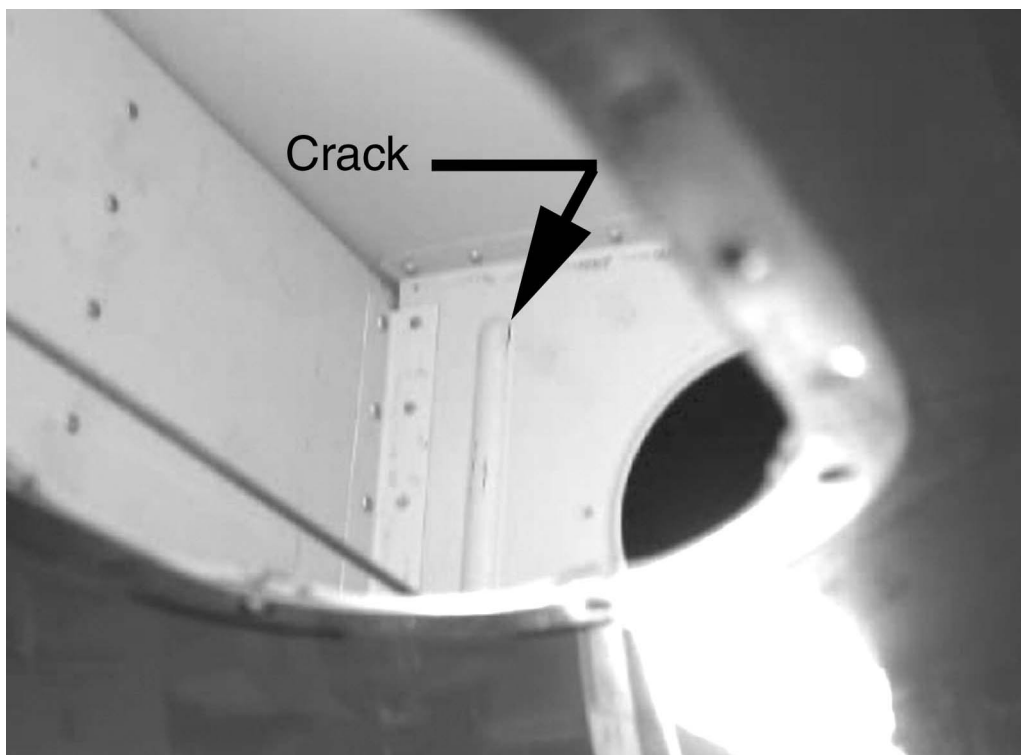
PURPOSE: A report has been received of a crack that may have been created during the manufacturing forming process at the edge of the forward stiffening bead in the Intermediate right hand Rib 35617-001, Sta. 123.15 that is located aft of the main spar. See Figure 1 showing the rib and cracked bead that was included in the report.

If not repaired, the crack could propagate to a point that could compromise the structural integrity of the rib.

2. Visually inspect the forward bead in both Wing Station 123.15 ribs for cracks. See Figure 1.
3. If the beads are not cracked or the ribs were manufactured prior to 05/14/01 without the forward bead, then no further action is required. Reinstall the access plates and make the appropriate Log Book entry.

4. If cracks are found at the edge of the bead as shown in Figure 1, repair as follows:
 - a. Stop drill the ends of the crack with #50 (0.070) drill.
 - b. Place the P/N 104721-002 Reinforcement Doubler (same doubler can be used on either the right or left hand rib) on the top of the cracked bead.

- c. Use masking tape or similar device to keep the repair doubler centered on the bead during Step d.
 - d. Open one of the top, aft predrilled holes in the repair doubler through the rib web to .143/.146 diameter and install a cleco.

- e. Repeat Step d. for one of the bottom forward predrilled holes in the repair doubler.
 - f. With the clecos installed, open the remaining predrilled holes in the repair doubler, thru the web to .143/.146 diameter and install CR3243-4-01 CherryMax rivets (P/N 522-906).

- g. Remove the clecos and install the remaining rivets.
- h. Reinstall the access plates and make appropriate Log Book entry.

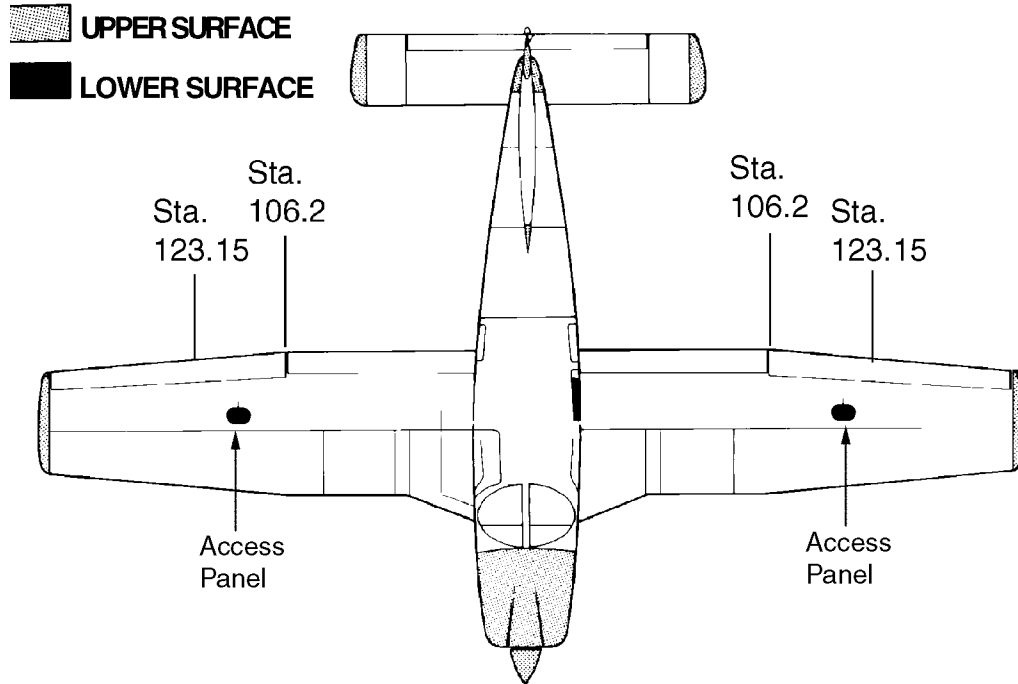
Figure 2

1. Gain access to inspect the subject ribs through an access opening in the lower skin that is located between Sta. 106.19 and Sta. 123.15 ribs, aft of the main spar, in each wing. See Figure 2.
