SERVICE BULLETIN

NO. 1242

RUDDER PEDAL ASSEMBLY INSPECTION

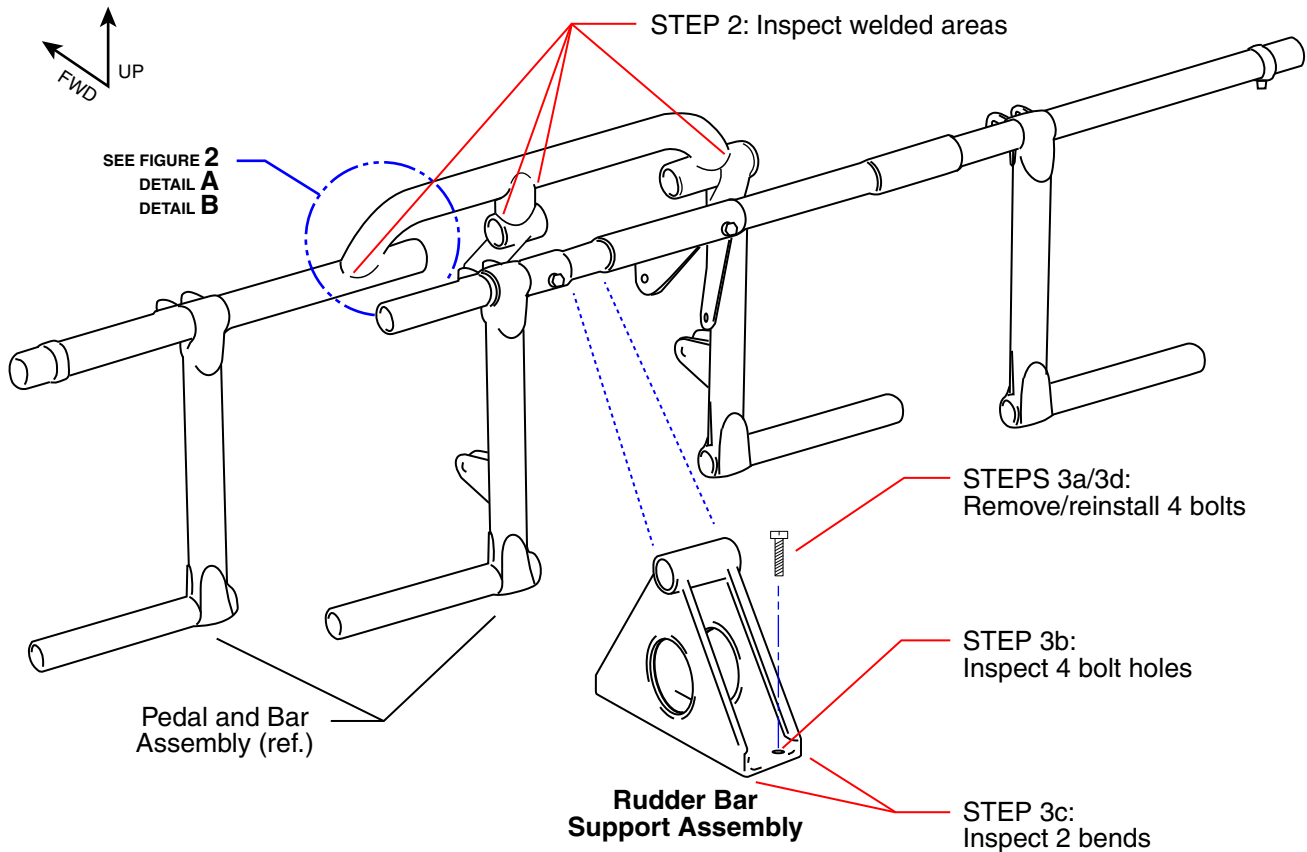
Figure 1
Rudder Pedal Installation (Typical)

A review of the service history on the affected airplanes reveals that, over time, cracks may develop in specific locations on the pedal and bar assembly and the rudder bar support assembly. This service bulletin provides a schedule and instructions for the inspection of these critical components for cracks, and for modification or replacement, on condition.

Visually inspect all welds, with specific emphasis on the locations identified in Figure 1.

- b. Visually inspect the four (4) bolt holes for cracks and elongation. See Figure 1. The diameter of the four bolt holes should measure 0.250 +0.005/-0.001 inches.
- c. Visually inspect the two (2) sheet metal bends common to the base for cracking, the entire length of each bend, both inner and outer surfaces. See Figure 1.
- d. Reinstall the four (4) bolts that secure the rudder bar support assembly to the cockpit floor. Refer to the appropriate section or chapter of the applicable Piper maintenance manual for the required installation torque for threaded fasteners.

NOTE: Any cracked components must be replaced prior to next flight.

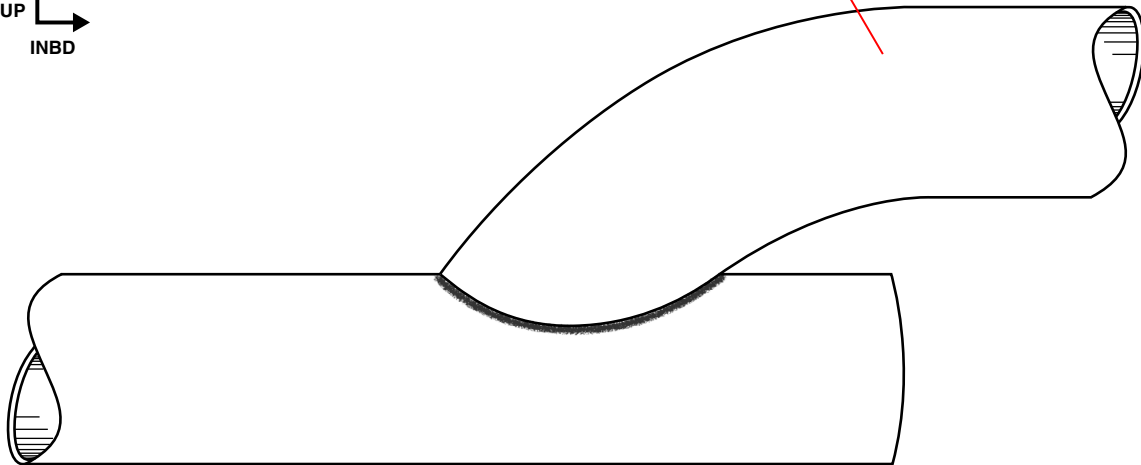
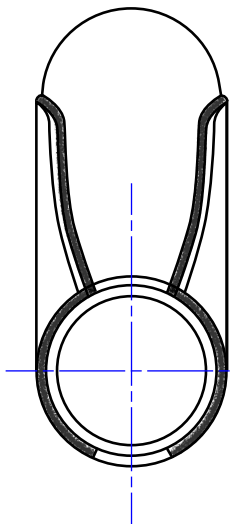
DETAIL A

- Examine the area identified in Figures 1 and 2 to determine which rudder bar assembly configuration is installed on the airplane.
 - If the rudder bar assembly conforms to Figure 2, Detail B, the airplane is already in compliance with Service Letter (SL) 671, and/or a replacement rudder bar assembly has been installed which includes these features. No modification is required. Proceed to Part II.
 - If the rudder bar assembly conforms to Figure 2, Detail A, modification is required. Proceed to Step 2, below.

- Examine the area to be modified for cracks, using the inspection criteria described in Part II. Any cracked components must be replaced prior to proceeding.
- Order one each of Piper part numbers (P/N) 99938-000 and 99938-001 rudder bar straps. TIG weld in place as shown in Detail B, per Chapter 4 of AC 43.13-1B (or latest revision). After welding, relieve residual stress in the affected area: Heat with a non-carburizing torch flame to 1,000°–1,100° F (538°–593° C) (a brown red color) then air cool to room temperature. All welding must be performed by a certified welder.

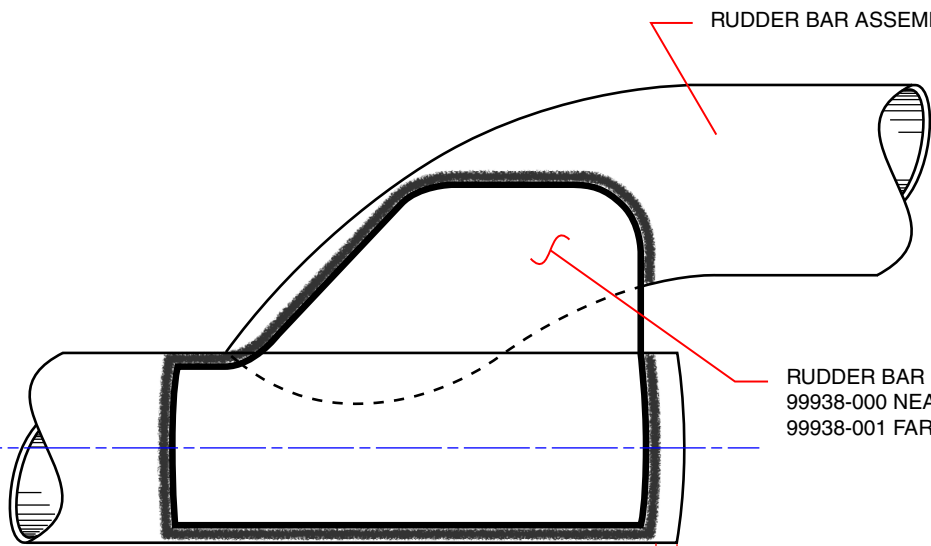
DETAIL B

RUDDER BAR STRAPS:
99938-000 NEAR SIDE
99938-001 FAR SIDE

0.10 IN. → ←

- All materials are 4130 normalized steel.
- The rudder bar tubes have a nominal outside diameter of 0.875 inches and nominal wall thickness of 0.058 inches.
- P/N 99938-000 and 99938-001 rudder bar straps are made from sheet steel with a nominal thickness of 0.040 inches.
