SERVICE BULLETIN

NO. 1245A

SUBJECT: STABILATOR CONTROL SYSTEM INSPECTION

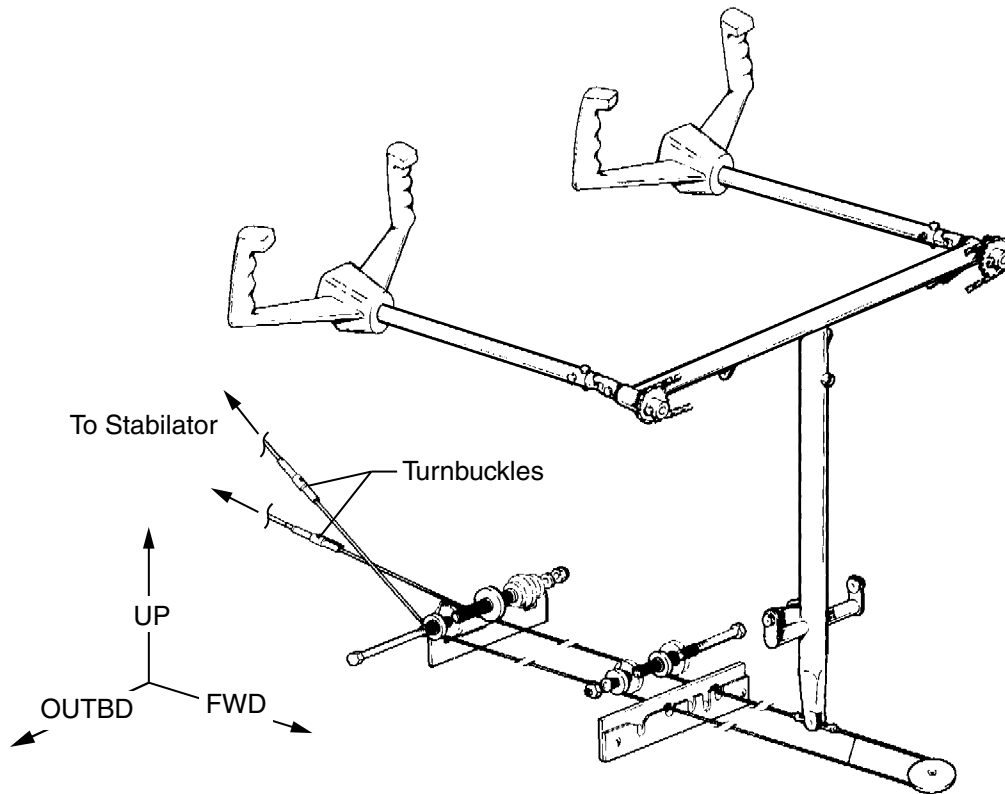
Figure 1
Stabilator Control Cables (Typical)

Existing Instructions for Continued Airworthiness (i.e., the appropriate Piper Maintenance Manual and associated Service Publications) include an inspection of all flight control pulleys, cables, fittings and turnbuckles on a recurring basis. However, service history suggests that over time, the turnbuckles used in the stabilator flight control cable system may develop cracks or corrosion which may not be detected during these inspections.

3. Remove and retain the access cover from the rear cabin bulkhead, in order to gain access to the tailcone area.
4. Identify the two (2) stabilator flight control cable turnbuckles, which are located inside the tailcone, directly aft of the rear cabin bulkhead. See Figure 1. Using procedures described in the appropriate Service/Maintenance Manual, disassemble the turnbuckle bodies to facilitate a complete inspection of the turnbuckle bodies and associated cable terminals.
5. Clean the turnbuckle bodies and associated cable terminals thoroughly with Methyl Ethyl Ketone (MEK) or acetone prior to inspection. The non-threaded surfaces of the turnbuckle body and cable terminals may be cleaned using Scotch-Brite™ General Purpose Green Scouring Pad 96 or 105b.

6. Using a 10X magnifier, a mirror and a suitable light source, carefully examine the entire surface of each turnbuckle, cable terminal, and adjacent portion of the flight control cable, inspecting for cracks, corrosion, or broken cable strands. Any evidence of cracks or cable fraying, however minute, is cause for replacement. Any evidence of corrosion that remains after accomplishing the cleaning instructions above is cause for replacement.

7. Using procedures described in the appropriate Service/Maintenance Manual, reassemble the turnbuckle bodies and associated cable terminals. Rig and adjust stabilator travel and stabilator control cable tension.
