SB10-8A

SUBJECT: Hartzell Engine Technologies Service Bulletin 040A – Turbocharger CHRA contamination

Bulletin No. 040 A

TURBOCHARGER CHRA CONTAMINATION

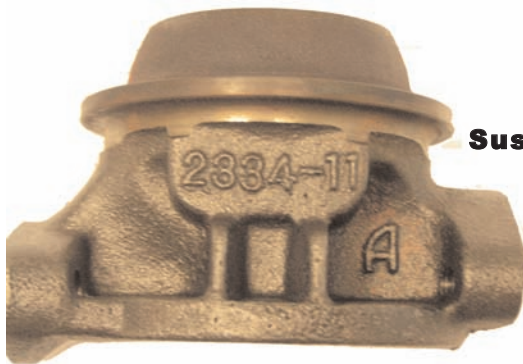
Figure 2 - Foundry Mark "Slanted A"

3. Using Figures 2, 3, and 4, identify the foundry mark located on the CHRA center housing as shown. Those with a circled "JT" are not affected and may proceed to the "Return to Service" section step 3 & 4. If a "slanted A" appears, continue with the DISASSEMBLY and CLEANING sections.

Suspect

4. If it has been determined that the CHRA center housing is affected per Table 1 and IDENTIFICATION section above, the turbocharger must be removed and disassembled to isolate the CHRA center housing.
5. Utilizing the most current Service Manual or Service Instructions of the applicable engine or airframe manufacturer, remove the turbocharger from the engine. To avoid the possibility of debris entering the turbocharger system connections, cap all open lines and ducts.

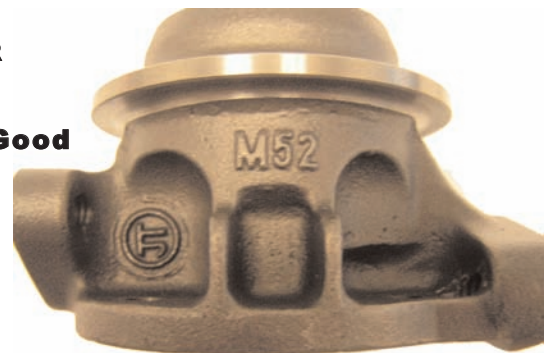
Figure 3 - Foundry Mark "JT"

Good

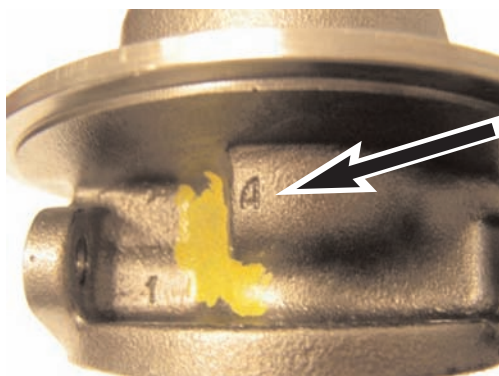
Foundry Mark May Also Be An Indented "Slanted A"

Suspect

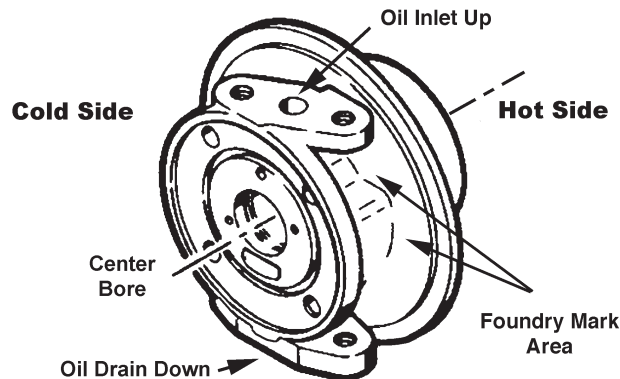
Figure 4
Typical CHRA
Center Housing

Hartzell Engine Technologies LLC (HET) has become aware of a condition affecting certain turbocharger center housing rotating assemblies (CHRA) where debris may not have been removed after the machining operation. The debris could enter the normal oil flow to the turbine wheel shaft assembly resulting in seizure of the shaft and/or turbine wheel head separation. This condition may also lead to a loss of engine oil. Either condition may lead to a complete loss of turbocharger function without warning as well as a partial or complete loss of engine power. Since this debris is expected to enter the oil stream quickly, the effects listed above can also occur quickly. The instructions herein identify the two manufacturing sources for the CHRA center housings of which only one is affected.

- Wearing protective Rubber Gloves, place CHRA center housing (Figure 4) into the bucket and soak for a minimum of 30 seconds. If the housing has coking or other stubborn deposits, allow to soak longer.

- After soaking, agitate center housing by hand in the bucket for a minimum of 15 seconds in each of the following directions: Center bore vertical, cold side down, center bore vertical, cold side up, oil drain down, and oil drain up. *Reference points shown in Figure 4.*

- Using the large nylon bristle brush, insert into center bore and oil outlet cavity. Scrub for 3 seconds minimum. Using the small nylon bristle brush, insert into the oil inlet and drain cavities. Work brush around the edges inside the cavity where chips and burrs may be located.
