SERVICE BULLETIN

No. 561

Piper Aircraft Corporation

Battery Power Lead Relocation

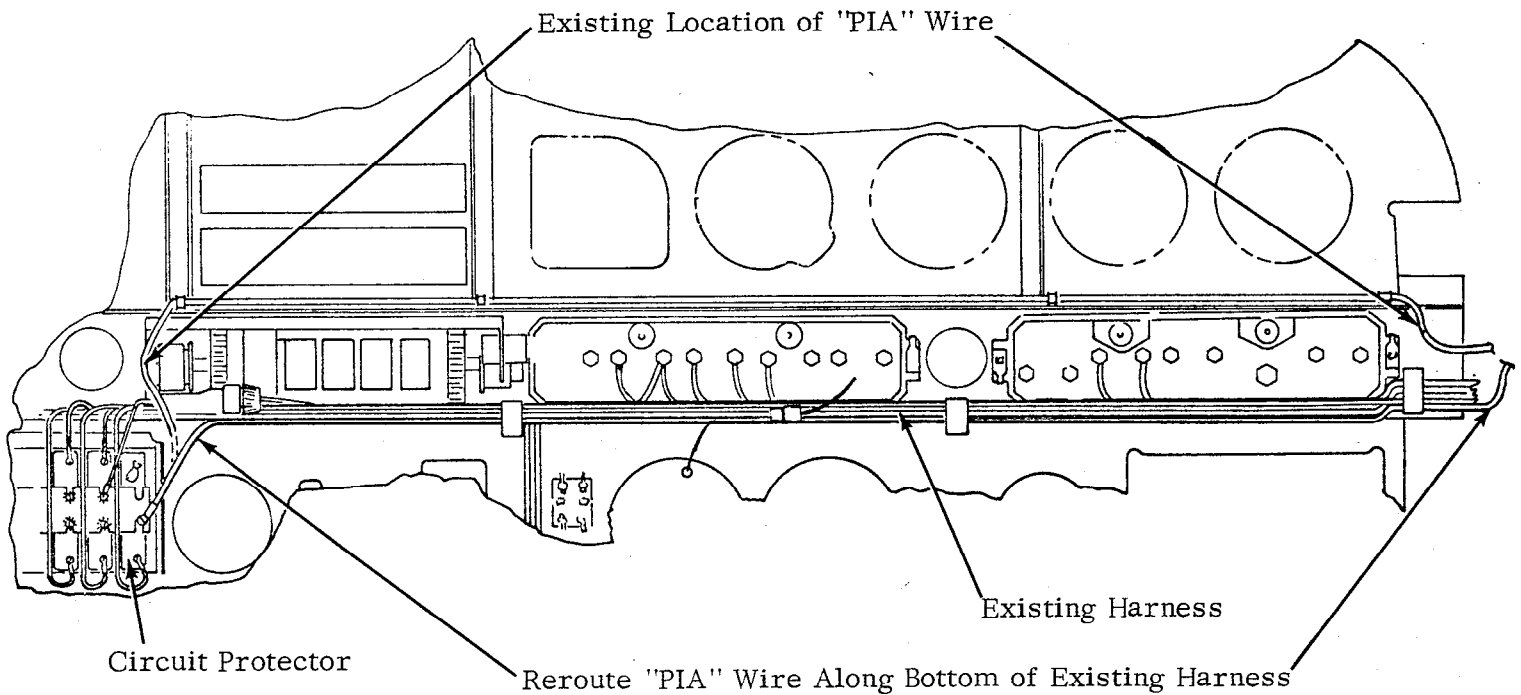
REAR VIEW OF INSTRUMENT PANEL

Purpose: It has been determined that the battery power lead that attaches to the DC bus, and is routed in close proximity to the fuel gauges, can induce an electrical field into the coils of the fuel quantity gauges. The amount of induced electrical field will depend upon the amount of electrical equipment turned on by the pilot. This induced field could cause the fuel quantity gauges to read as much as four (4) gallons fuel remaining when the tanks are actually empty.

5. Refer to sketch:
 - a. Remove the four (4) each clamps securing the (P1A) wire to the top of the instrument panel channel. The clamp screw located between the radio stacks (over the dimmer control) is secured in a nut plate. This screw should be reinstalled after clamp is removed. This screw may be reached through the right radio opening.

- b. Disconnect the wire (P1A) from the circuit breaker bus bar and pull to the left (Pilot) side panel.
 - c. Reinstall the wire (P1A) under the instrument panel wire bundle, securing the wire with the existing strap clamps. It may be necessary to secure the wire to the existing wire bundle between strap clamps.

- d. Attach the wire to the bus bar using hardware and location removed in step "b." above. Any extra wire should be positioned behind the left side panel.
