SERVICE BULLETIN

No. 625A

Piper Aircraft Corporation

Subject: Fuel and Vapor Return Lines Support

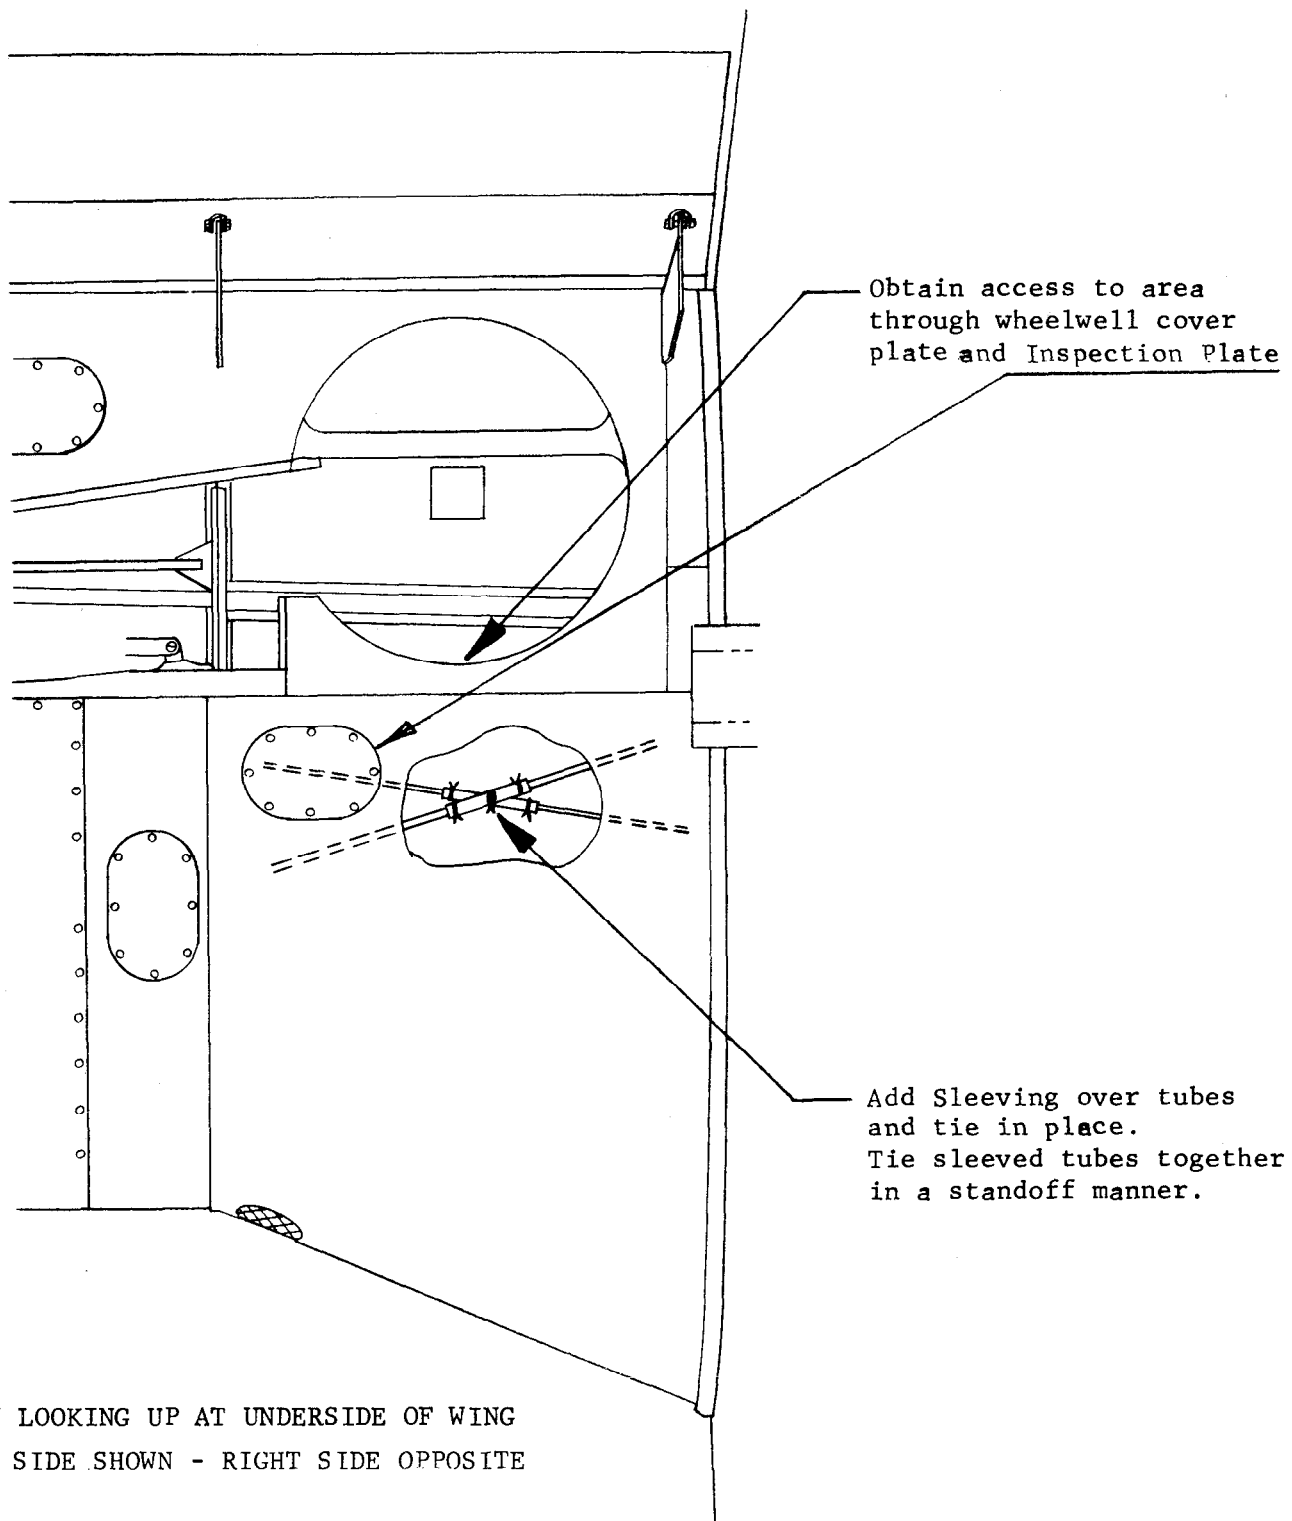
The possibility exists that chaffing can occur between the fuel line and the vapor return line in the left and right wings.

If this condition exists and is left uncorrected, the chaffing can lead to the failure of either line resulting in fuel leakage and possible engine failure.

1. Gain access to the area forward of the wheel well, (left and right side, as shown on the attached sketch) by removing wheel well cover plates and inspection plates.
2. Install protection sleeves (Piper Part Number 63882-073V) over the lines and secure in place with ty-wraps (Piper Part Number 488 702V) as indicated on sketch on left and right side.

3. Tie sleeved lines together in a stand-off manner using additional ty-wraps.
4. Re-install access plates removed in Instruction 1.
5. Make appropriate logbook entry of compliance with this Service Release.
