SERVICE *No.884* BULLETIN

Piper Aircraft Corporation
Vero Beach, Florida, U.S.A.

Date April 8, 1988 S/M

Lock Wiring of V-Band Couplings

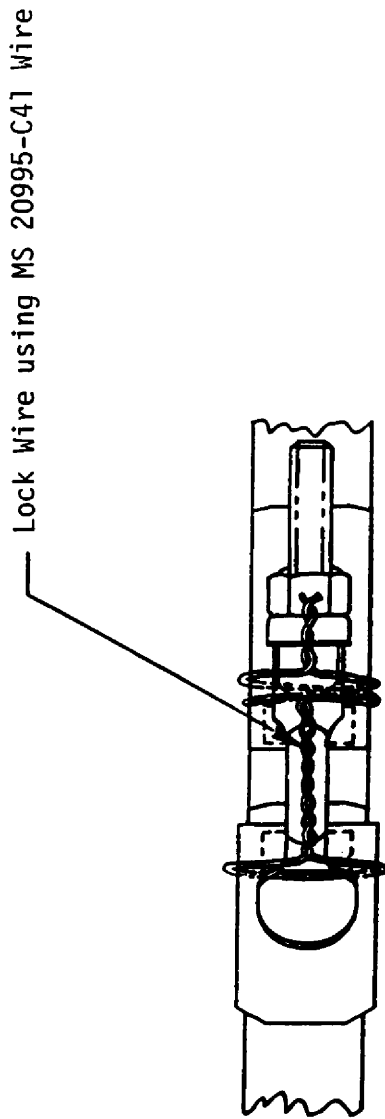
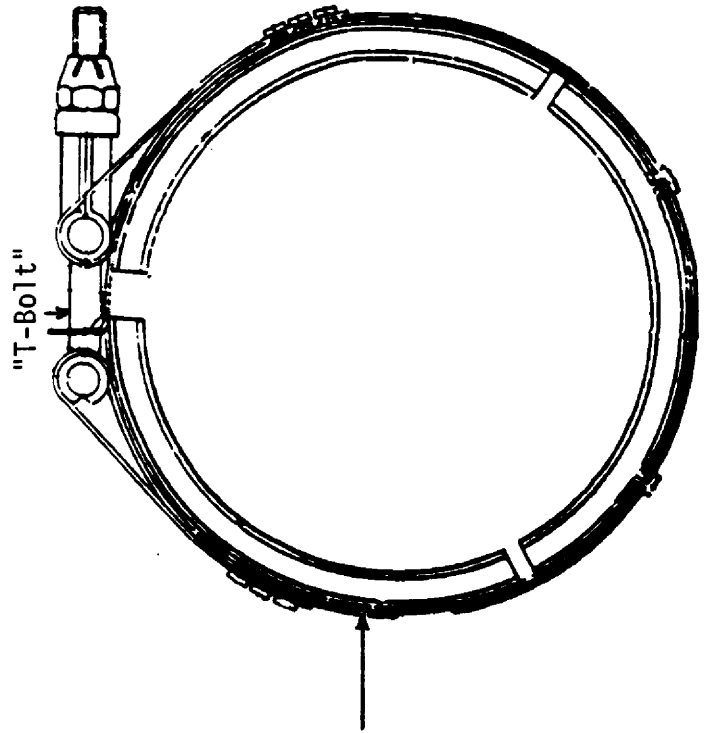
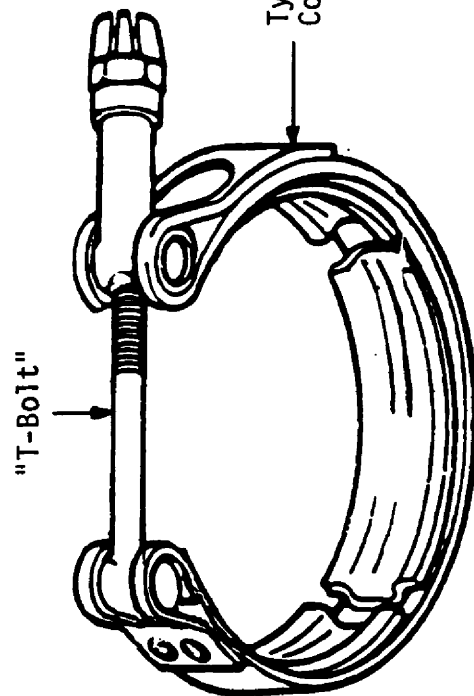
SKETCH "A"

PURPOSE: Reports have been received of broken "T-bolts" in the V-Band Couplings used in the exhaust, bleed air and cabin heat systems on various Piper Airplanes. The failure of a T-bolt can allow the coupling to separate, permitting hot exhaust gases or bleed air to be expelled, creating a fire hazard.

1. Refer to the applicable parts catalog to determine the number and location of V-Band Couplings on the affected aircraft.
2. Inspect all V-Band Couplings for security and integrity of T-bolts and lock wire (if installed). Refer to Sketch "A" attached.
3. If lock wire is damaged or missing, lock wire coupling using MS20995-C41 wire. Refer to Sketch "A".
4. Make an appropriate logbook entry of compliance with this Service Bulletin.
