Piper Aircraft Corporation  
Vero Beach, Florida, U.S.A.

# SERVICE No. 933A BULLETIN

Trunnion Replacement

PA 28R-201 Arrow III

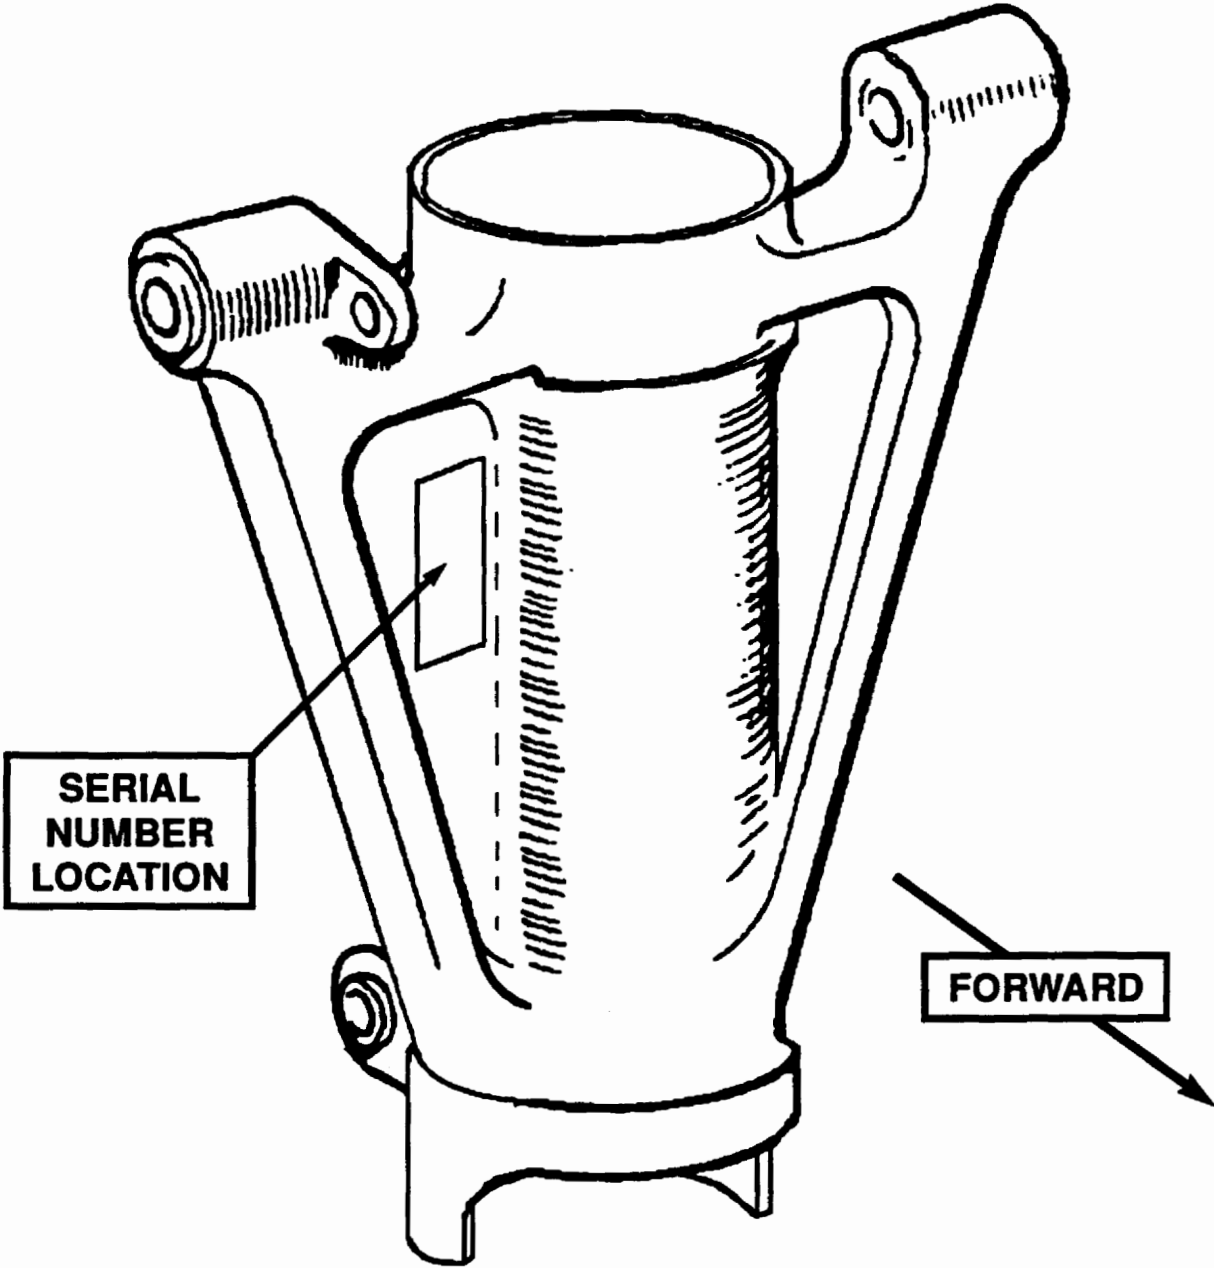
SKETCH "A"

1. Locate serial number etched on the nose gear trunnion. (See Sketch "A") This is located on the front of the trunnion on the left web as you look aft.

2. If the serial number falls between 15200 through 15313, the trunnion must be removed from service. Replace with Nose Gear Trunnion, Piper Part Number 67054-003 with serial number not in the effected range.
3. If the nose gear trunnion requires replacement, place aircraft on jacks and refer to the appropriate Service Manual for instructions and procedures for removal and reinstallation.
4. Following the nose gear trunnion replacement, perform gear retraction cycle check per appropriate chapter of the Maintenance Manual. Upon successful completion, remove aircraft from jacks.
5. Make an appropriate logbook entry of compliance with this Service Bulletin.
