Piper Aircraft, Inc.
2926 Piper Drive
Vero Beach, FL, U.S.A. 32960

SERVICE NO. 1161C BULLETIN

**RIB ASSEMBLY INSPECTION AND MODIFICATION –
FORWARD AND AFT WING RIBS, WS 49.25**

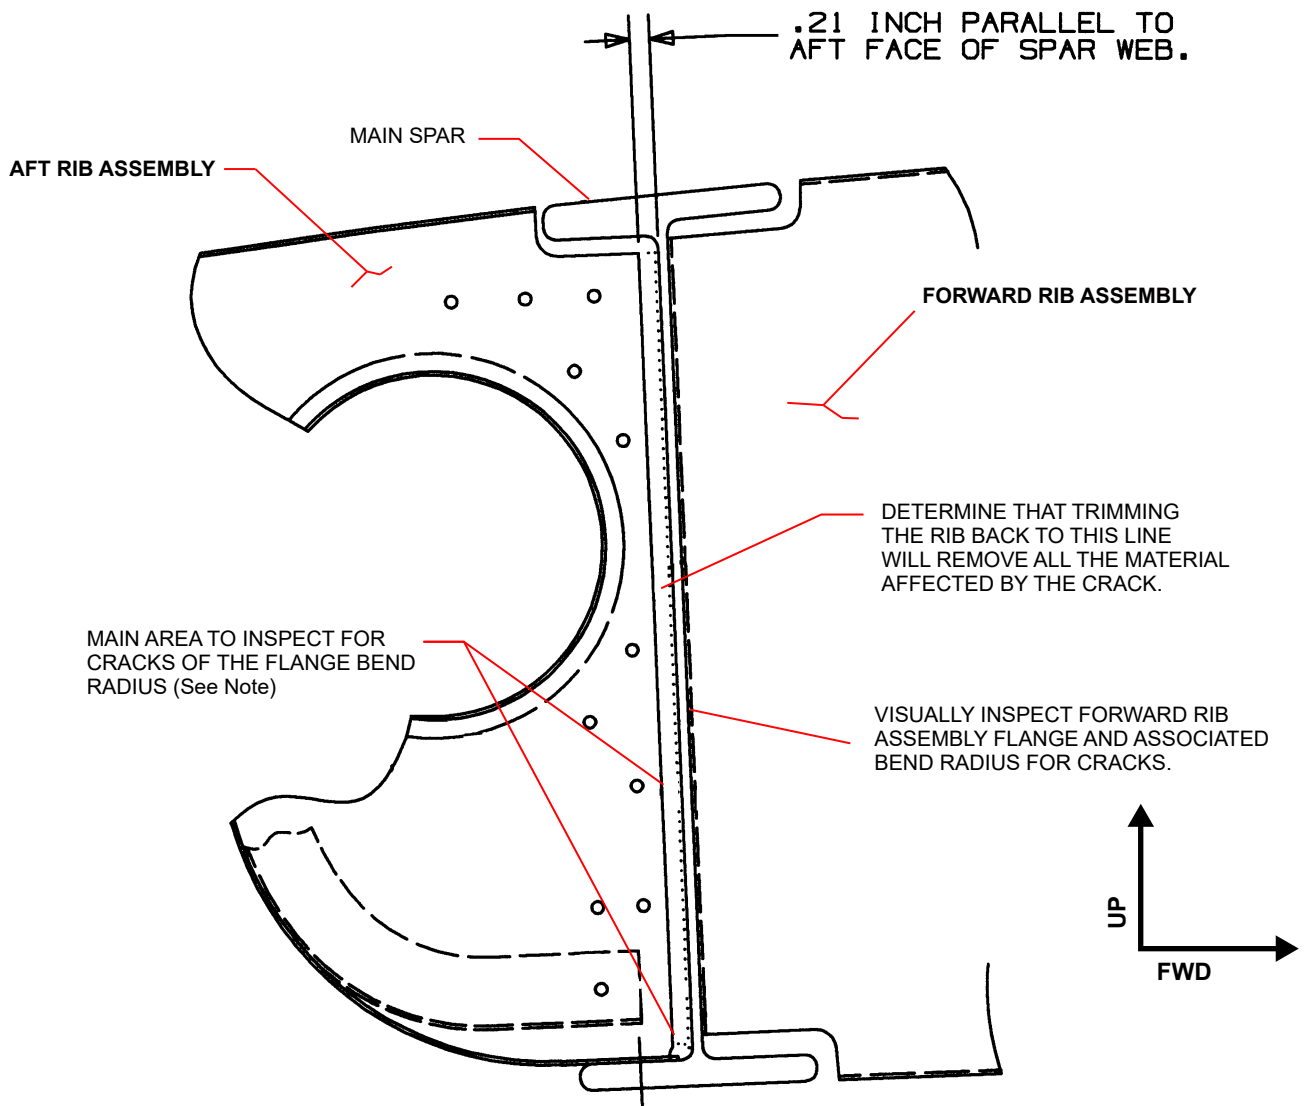
Figure 1

Under certain conditions, the rib assemblies on the forward and aft side of the main wing spar at wing station (WS) 49.25 may develop a crack, located vertically along the bend radius of the flange common to the main wing spar and the side brace attach fitting.

3. Inspect the aft rib assembly (LH wing and RH wing) for evidence of cracks in the bend radius of the flange common to the main spar web (as shown in Figure 1), using dye penetrant inspection techniques. Use guidance from FAA Advisory Circular AC43.13-1B.

- If a **crack is detected**, identify the path of propagation. Determine if trimming will remove all the material affected by the crack, as illustrated in Figure 1.

LOOKING OUTBOARD AT LEFT WING, WS 49.25
(RIGHT WING OPPOSITE)

Determine if trimming will remove all material affected by cracks or damage in the aft rib assembly

- If so, then install the appropriate kit (see Material Required section of this service bulletin). Kit installation will eliminate the recurring inspection requirements mandated by Part I of this service bulletin.

- If not, then replacement of the aft rib assembly is mandated.
 - If a replacement Rib Assembly – Aft Wing – WS 49.25, P/N 78475-000 through 78475-009, is installed, this **does not relieve the recurring inspection requirements** of this service bulletin. However, the **recurring inspections as described in Part I are relieved** if the applicable kit P/N 767-397 or 767-398 is also installed, and if the kit instructions are marked drawing number 88373, revision J (or later).

- If a replacement Rib Assembly – Aft Wing – WS 49.25, P/N 78475-010 or higher, as defined in Table 1, is installed, this **relieves the recurring inspection requirements** described in Part I of this service bulletin. (Installation of either kit P/N 767-397 or 767-398 is not required, in this case.)
