Piper Aircraft, Inc.
2926 Piper Drive
Vero Beach, Florida, U.S.A. 32960

SERVICE NO. 1197B

Date: May 3, 2010 (S) (M)

CONTROL WHEEL SHAFT INSPECTION

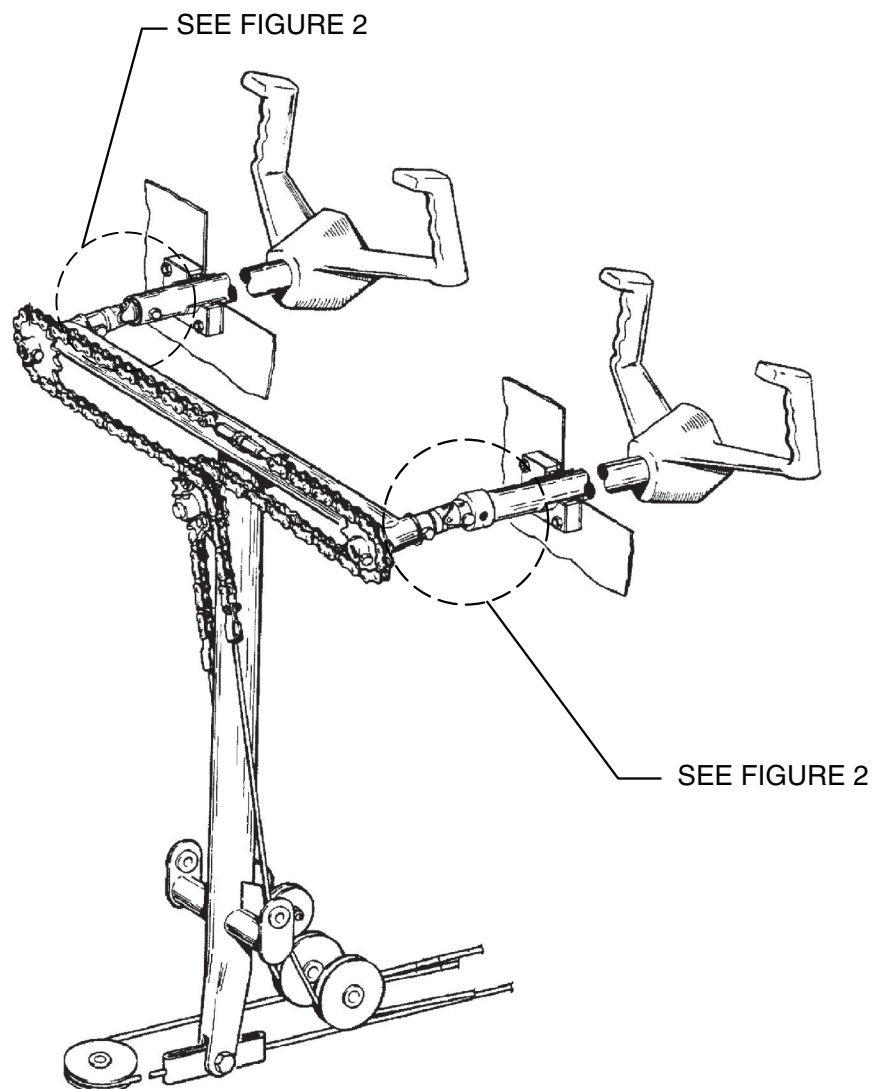
Figure 1
Control Column Assembly

1. Gain access to the forward end of the control wheel column between the instrument panel and the forward firewall.
2. Locate the shaft and the universal joint (2 per aircraft), which are fastened together with a threaded taper pin, as shown in Figures 1 and 2. These components are installed on the aft side of the T-bar assembly.

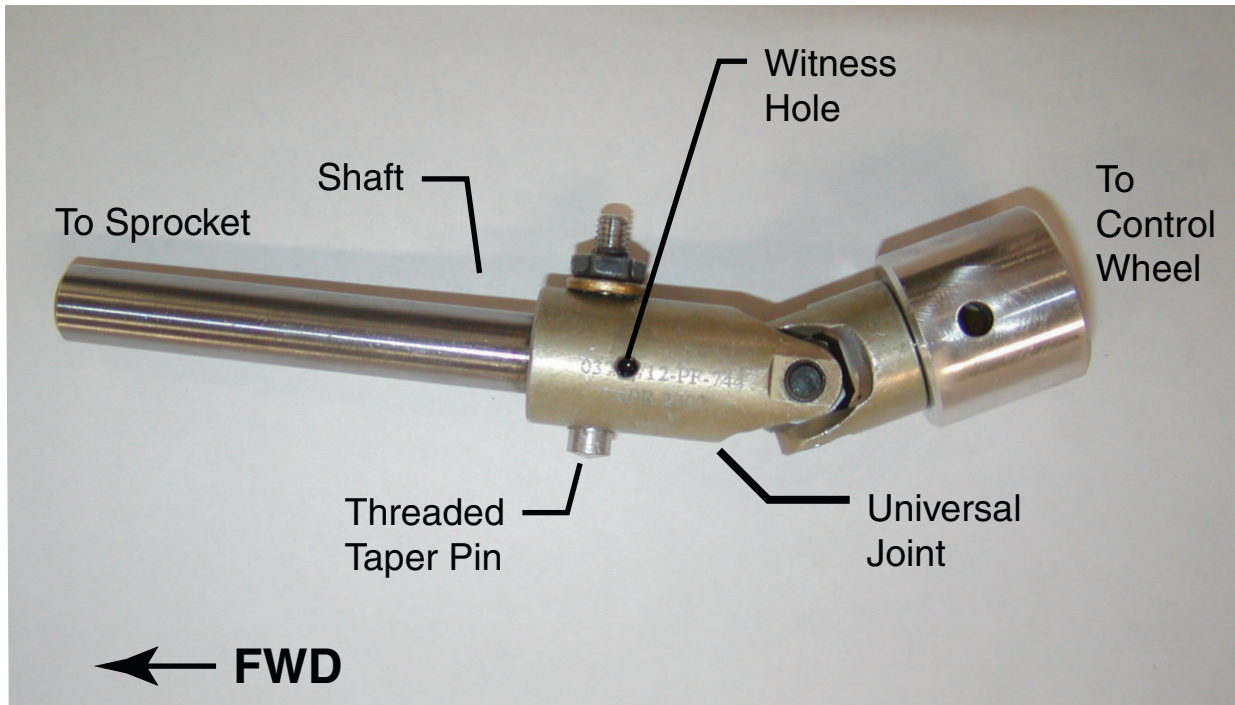
Figure 2
Shaft Fastened to Universal Joint

Piper has received two field reports of incorrectly-assembled control wheel shafts. Specifically, the shaft common to the sprocket and the universal joint (both pilot and copilot sides) may not have been inserted fully into the universal joint prior to match-drilling the hole for the taper pin that fastens the shaft to the universal joint. The cause of this condition is unknown. Holes mis-drilled in such a manner may appear visually to be acceptable, when in fact the hole in the shaft may be too close to the end of the shaft, causing a significant reduction in joint strength.

Left uncorrected, this condition could lead to separation of the control wheel shaft, resulting in loss of pitch and roll control.

3. Inspect each universal joint for the presence of a witness hole, as shown in figure 2. Most aircraft will have this witness hole feature. However, some early model aircraft may not have a witness hole. If no witness hole exists, proceed to step 5.

4. Insert a 3/64 inch diameter drill rod into each witness hole as far as it will go with hand pressure. Measure the depth of penetration:
 - If the drill rod penetration depth measures approximately 0.2 inches, this indicates that the drill rod is bottoming out against the near side of the fully inserted shaft. This installation is correct. Proceed to step 8.

- If the drill rod penetration depth exceeds 0.2 inches, this indicates that the drill rod is bottoming out against the far side inner wall of the universal joint, and is not making contact with the shaft. Universal joints with this condition may have a shaft with inadequate edge distance, and will require further inspection. Proceed to step 5.

5. If the inspection from step 3 identifies a universal joint without a witness hole, or if the inspection from step 4 identifies a shaft with potentially inadequate edge distance, temporarily remove the taper pin (or bolt, as applicable) and disassemble the universal joint from the shaft.

- If the distance from the end of the shaft to the centerline of the hole for the taper pin (or bolt) measures 0.19 inches or more, the edge distance is adequate, and existing parts may be reassembled. Proceed to step 7.
- If the distance from the end of the shaft to the centerline of the hole for the taper pin (or bolt) measures less than 0.19 inches, the edge distance is inadequate, and replacement of the shaft is required. Proceed to step 6.
