2926 Piper Drive Vero Beach, FL, U.S.A. 32960

SERVICE NO. 1197E BULLETIN

Date: November 2, 2017 (S) (M)

CONTROL WHEEL SHAFT INSPECTION

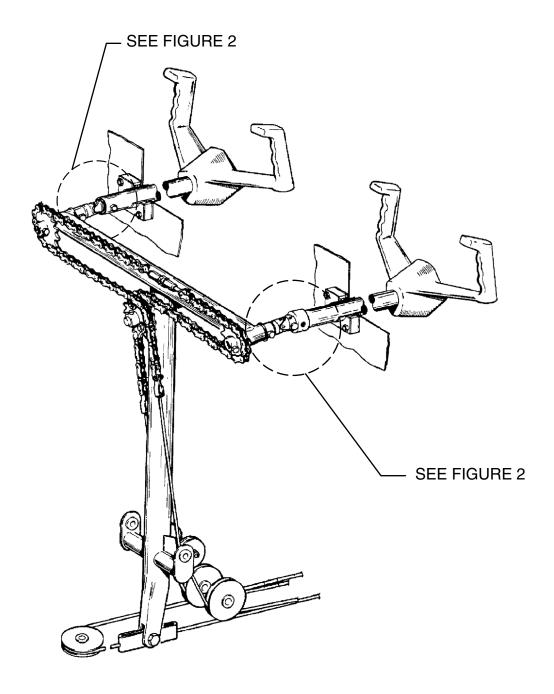
Figure 1
Control Column Assembly

- RC Gain access to the forward end of the control wheel column between the instrument panel and the forward firewall.
- Locate the shaft and the universal joint (2 per aircraft), which are fastened together with a threaded taper pin, as shown in Figures 1 and 2. These components are installed on the aft side of the T-bar assembly.

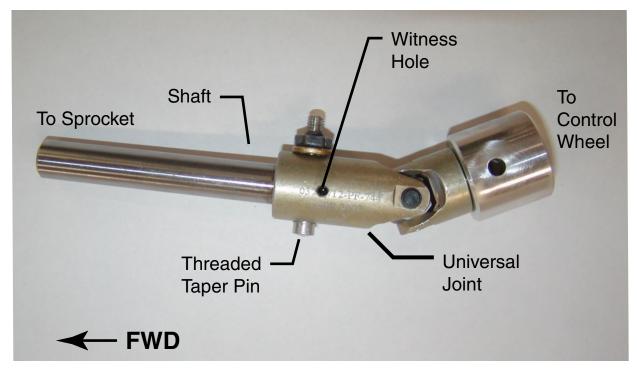
Figure 2
Shaft Fastened to Universal Joint

- 3. RC Inspect each universal joint for the presence of a witness hole, as shown in Figure 2. Most aircraft will have this witness hole feature. However, some early model aircraft may not have a witness hole. If no witness hole exists, proceed to step 5.

- 4. RC Insert a 3/64 inch diameter drill rod into each witness hole as far as it will go with hand pressure. Measure the depth of penetration:
 - If the drill rod penetration depth measures approximately 0.2 inches, this indicates that the drill rod is bottoming out against the near side of the fully inserted shaft. This installation is correct. Proceed to step 9.

- If the drill rod penetration depth exceeds 0.2 inches, this indicates that the drill rod is bottoming out against the far side inner wall of the universal joint, and is not making contact with the shaft. Universal joints with this condition may have a shaft with inadequate edge distance, and will require further inspection. Proceed to step 5.b.

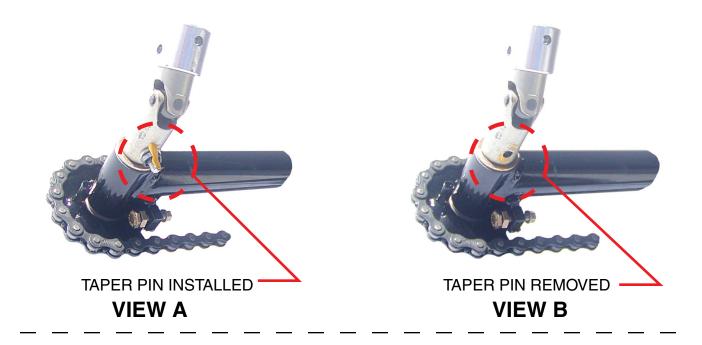
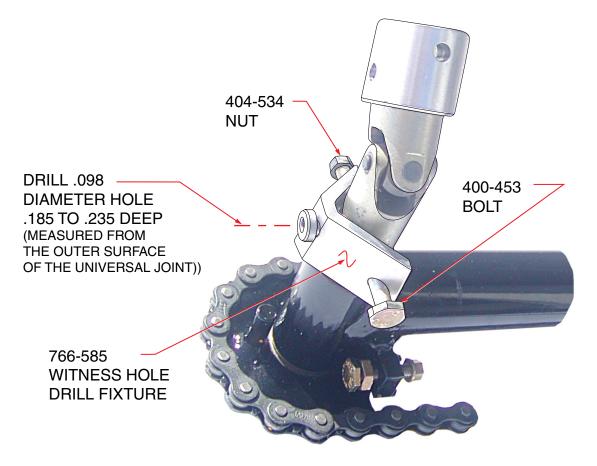
Figure 5
Witness Hole Drilling Procedure

766-585 WITNESS HOLE DRILL FIXTURE PINNED IN PLACE

NOTE: The Bolt, P/N 400-453, and Nut, P/N 404-534, are components of Witness Hole Drill Fixture, P/N 766-585. See Figure 5, View C.
