Piper Aircraft, Inc.
2926 Piper Drive
Vero Beach, FL, U.S.A. 32960

SERVICE NO. 1244C BULLETIN

**AFT WING ATTACH FITTING INSPECTION
REQUIREMENTS**

ATA/JASC: 5740

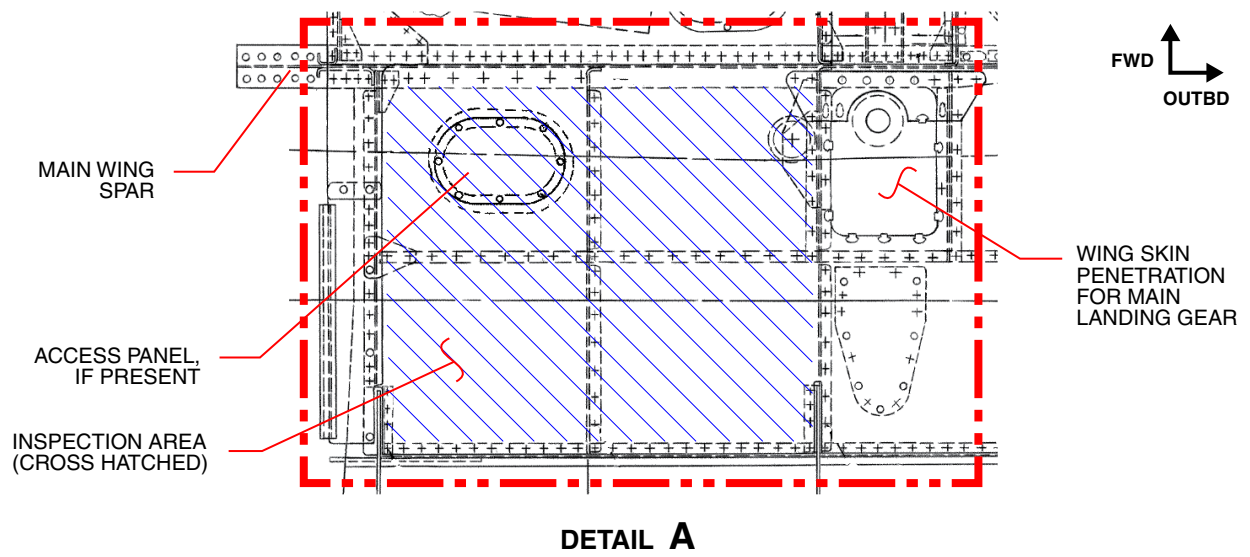
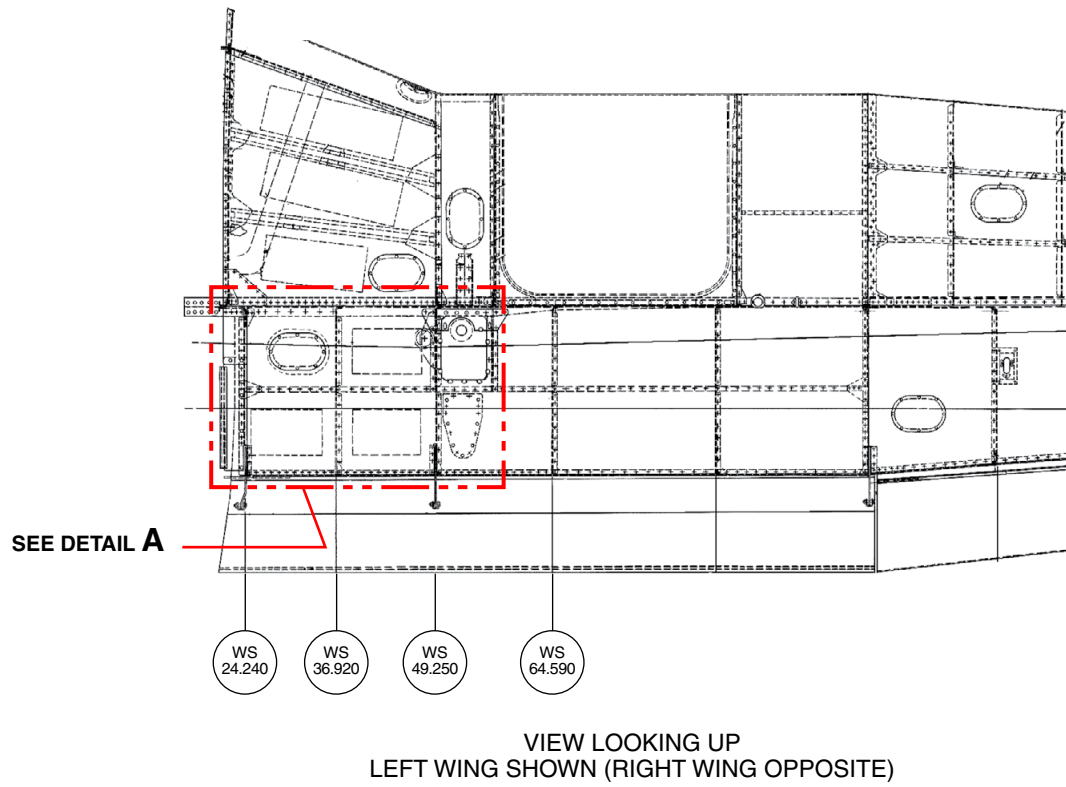
Figure 1
Access Panel Location

For the affected aircraft listed in Table 1 below, examine the lower wing skin, in the area aft of the main wing spar, and inboard of the main landing gear, for the presence of an access panel. See Figure 1.

NOTE: Some of the aircraft listed in Table 1 may not have an access panel that provides direct access to the inspection area. This access panel, if installed, will be located on the lower wing skin, between the main wing spar and the aft wing spar, and inboard of the main landing gear. This region is depicted by the shaded area shown in Figure 1. This access panel will be oval shaped, roughly eight (8) inches long and 5.50 inches wide. If no access panel is installed at this location, then access panels may be installed by ordering and installing Piper Kit – Inspection Access Hole, P/N 765-106. Each kit provides parts and instructions to install one access panel under both left and right wings, at a location that provides direct visual access to the inspection area.

- If an access panel already exists in the area identified in Figure 1, proceed to Step 3.
- If no access panel exists in the area identified in Figure 1, order and install Piper kit, Inspection Access Hole, P/N 765-106. Proceed to Step 3.

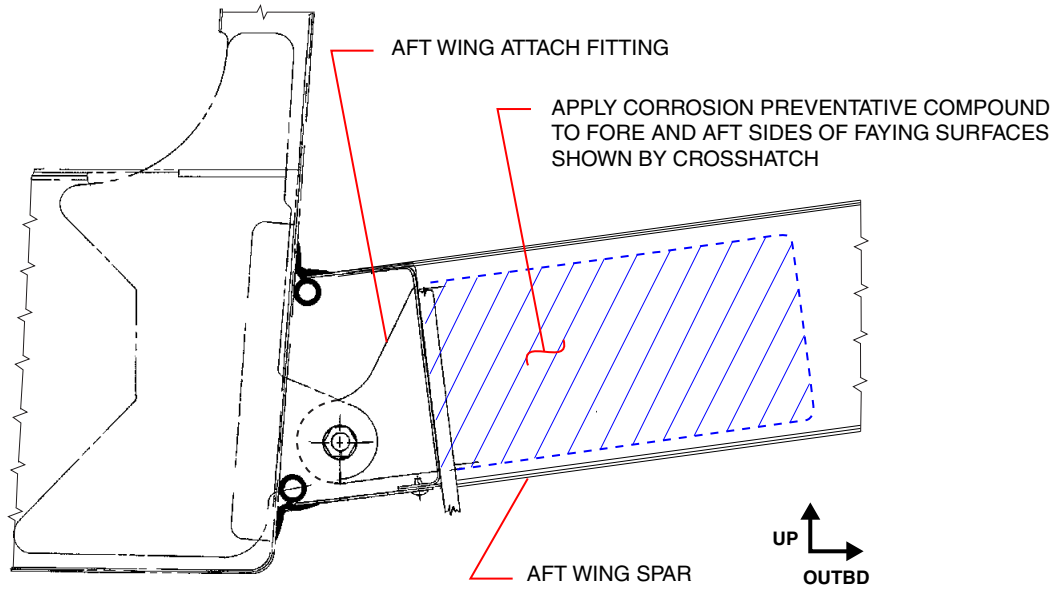
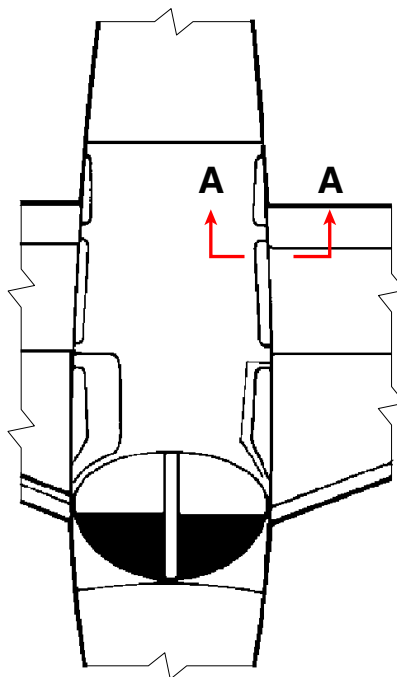
Figure 2
Aft Wing Attach Fitting

3. Identify the aft wing attach fittings which are riveted to the aft wing spars. See Figure 2. Using a solvent-based degreaser spray that conforms to SAE AMS 1525 (such as LPS Presolve Orange Degreaser) and/or an alkaline cleaner that complies with SAE AMS 1526 (such as Chemetall Ardrex 6333A), thoroughly clean the aft wing attach fittings and the adjacent wing spar structure (fore and aft sides of each wing spar), removing surface oil, grease, loose paint, and soil, followed by a clean water rinse and dry.

4. Carefully inspect for evidence of corrosion. The initial stages of corrosion are often masked by paint coatings and hidden under faying surfaces such as riveted lap joints. Since corrosion products occupy more volume than the original metal, carefully inspect these areas for irregularities such as blisters, flakes, chips, lumps, bulging skins and missing rivets.

- If no corrosion is present, proceed to Part III.
 - If superficial corrosion is detected, remove per FAA Advisory Circular AC 43.12-1B, Chapter 6, Section 7. After removal of the corrosion, verify that all the affected areas meet or exceed the minimum thicknesses in Table 2. If the affected areas meet the minimums, then treat the corrosion with guidance from AC 43.13-1B, Chapter 6, Section 8 or 10. Then, paint the affected areas using a good quality aircraft primer that complies with MIL-PRF-23377 (such as Akzo-Nobel 10P30-5). Proceed to Part III.

- If corrosion is detected, and removal of corrosion in the affected areas will result in a part thickness in any location that is less than the minimum values shown in Table 2, structural repair is required. Proceed to Part II.

1. Treat the area identified in Figure 2, View A–A, with Ardrox (Dinitrol) AV8, or other MIL-PRF-16173 Class I or II, Grade 1 or 4 compliant Corrosion Preventive Compound (procure locally, or order Piper P/N 89500-800). The treatment may be brushed or sprayed.
NOTE: Verify that all drain holes and drain passages are clear before proceeding.
2. Reinstall inspection plates and fairings. Perform a functional test of any system or component that may have been disconnected or removed.
3. Proceed to Part IV.
