Piper Aircraft, Inc.
2926 Piper Drive
Vero Beach, FL, U.S.A. 32960

SERVICE NO. 1355 BULLETIN

Date: February 25, 2022

TEE BAR ASSEMBLY INSPECTION

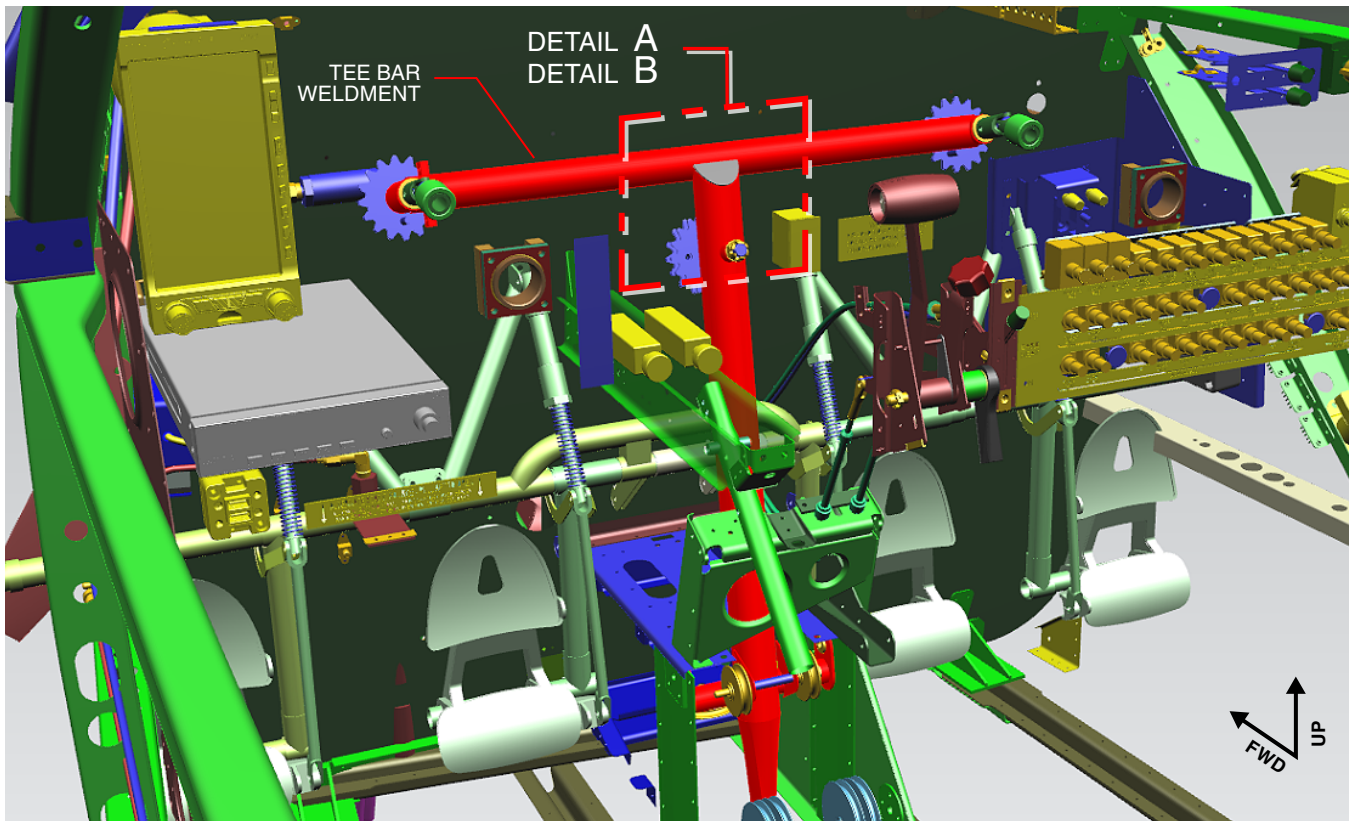
Figure 1
Tee Bar Assembly – Weldment

A review of service history reveals that cracks may develop in the tee bar assembly of the affected aircraft. This service bulletin provides instructions for the recurring inspection of the tee bar assembly for cracks. Replacement of the installed tee bar weldment assembly with the applicable new tee bar weldment assembly specified in Table 1 will eliminate the need for a recurring inspection.

1. Gain visual access to the top center portion of the tee bar assembly, as shown in Figure 1. Identify the configuration of the tee bar weldment assembly.
 - If the local area conforms to Figure 1, Detail A, then recurring inspections are required. Proceed to Step 2.
 - If the local area conforms to Figure 1, Detail B, then the tee bar assembly has already been modified in accordance with Part II, or has been replaced with a tee bar assembly containing the required features (i.e., gusset). No recurring inspections are required. Proceed to Part II, Step 2.
2. Examine the area shown in Detail A for cracks, with special emphasis on welded joints.

DETAIL A
LOOKING FORWARD AT
CONTROL COLUMN TEE BAR WELDMENT
WITHOUT GUSSET

DETAIL B
LOOKING FORWARD AT
CONTROL COLUMN TEE BAR WELDMENT
WITH GUSSET

NOTE: Modification of the tee bar assembly as described in Part II, or installation of a replacement tee bar assembly with the features shown in Figure 1, Detail B, will relieve the recurring inspection requirement in Part I.

- b. Perform a fluorescent dye penetrant inspection per FAA Advisory Circular AC 43.13-1B, Chapter 5, Section 5.
 - If any cracks are discovered, then the tee bar weldment must be replaced prior to next flight. Proceed to Part II.
 - If no cracks are discovered, apply primer and topcoat to bare metal, per the applicable Piper Airplane Maintenance Manual (AMM) or Service Manual (SM) and FAA Advisory Circular AC 43.13-1B, Chapter 6. Proceed to Step 3.
3. Perform a functional check on any systems that were disturbed during this inspection.
 4. Make a logbook entry documenting compliance with Part I this service bulletin.

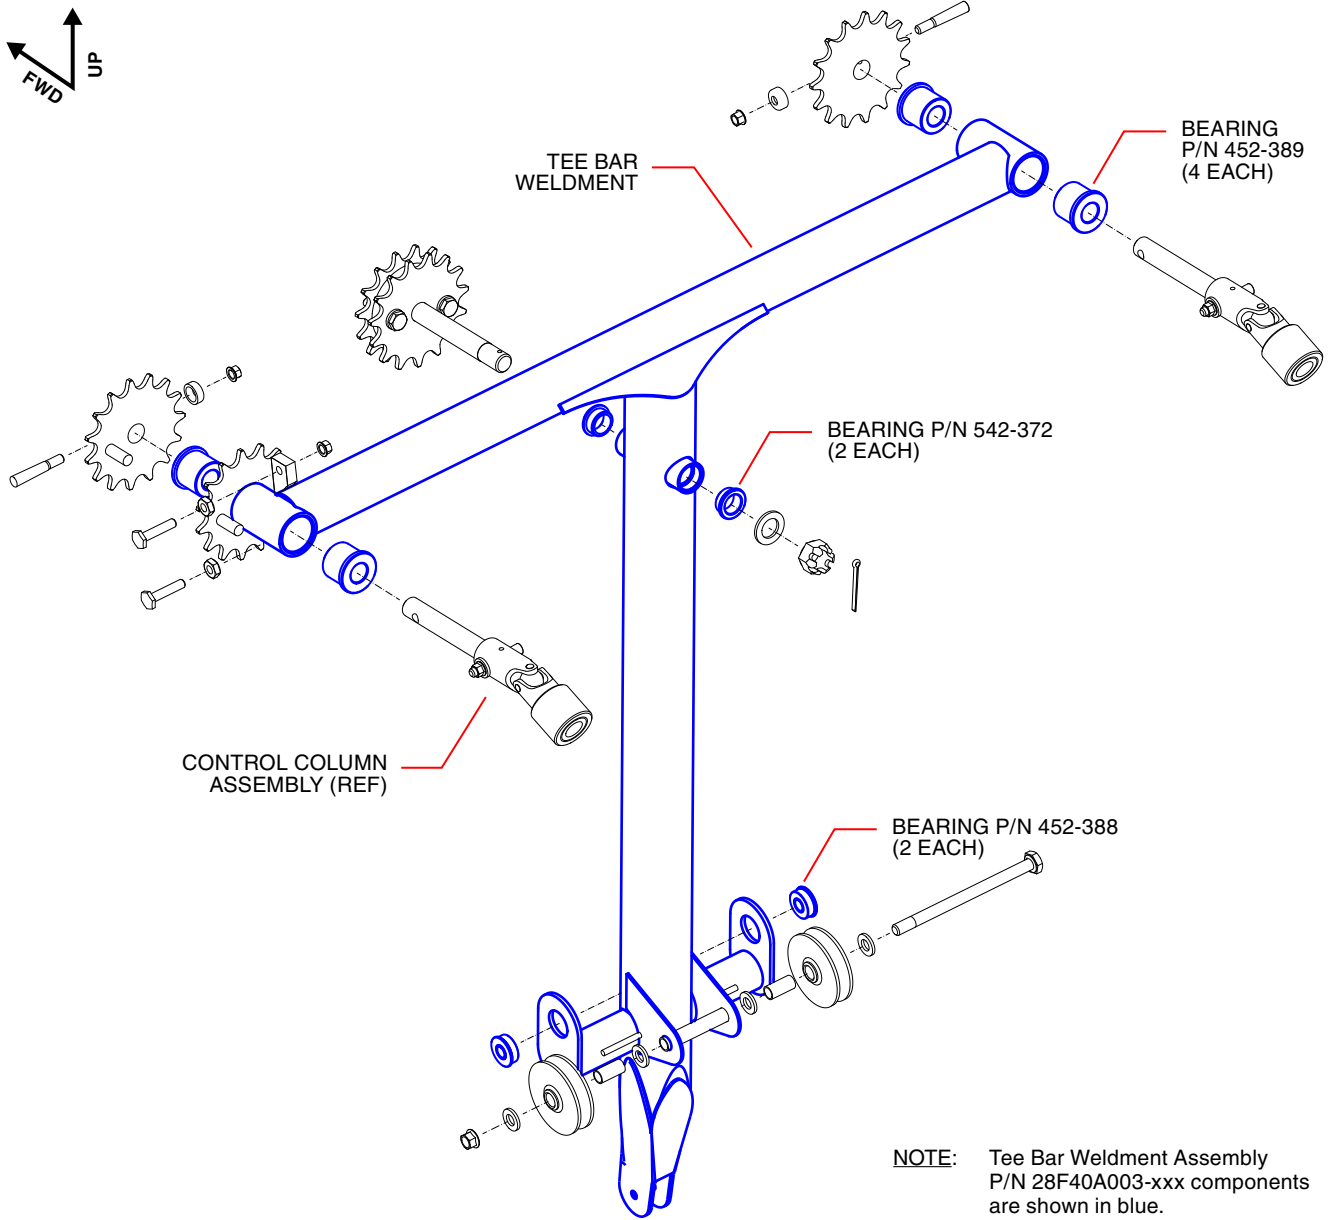
Figure 2

Tee Bar Assembly – Weldment Assembly Installation

4. Assemble the control wheel tee bar assembly (refer to Figure 2): Install the sprockets, control wheel columns, and hardware, which were removed from the original weldment assembly in the previous step, onto the replacement tee bar weldment assembly.
