Piper Aircraft, Inc.
2926 Piper Drive
Vero Beach, FL, U.S.A. 32960

SERVICE NO. 1355A BULLETIN

TEE BAR ASSEMBLY INSPECTION

SB 1355A clarifies instructions and corrects a reference error

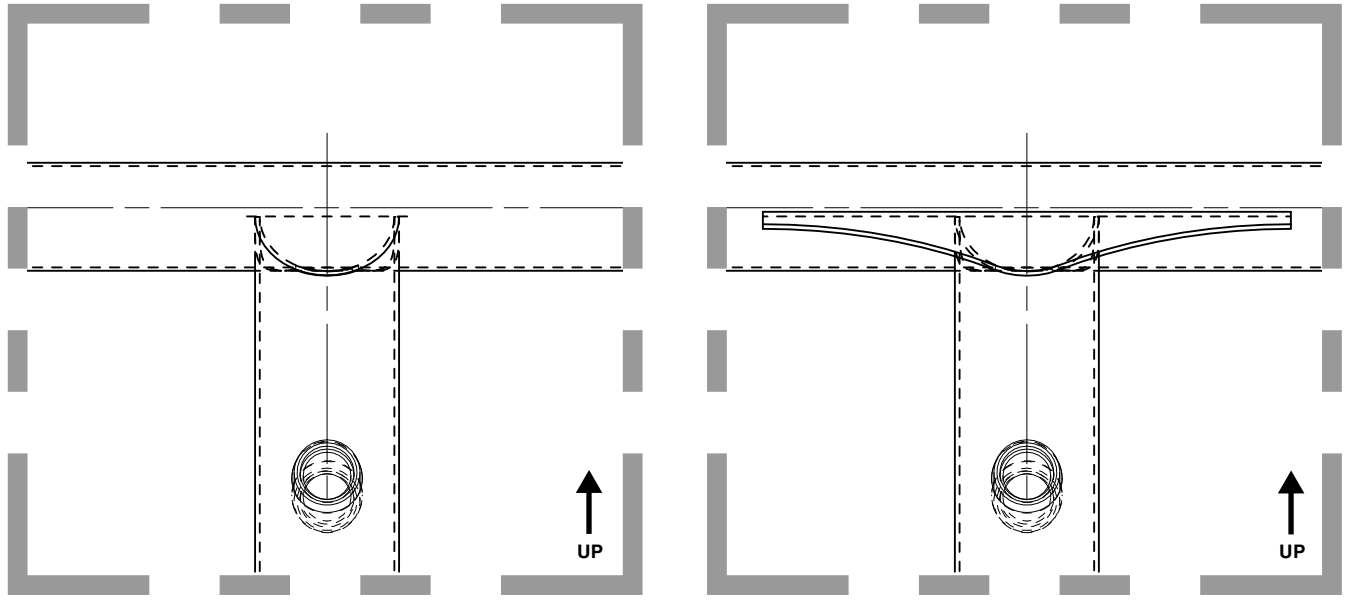
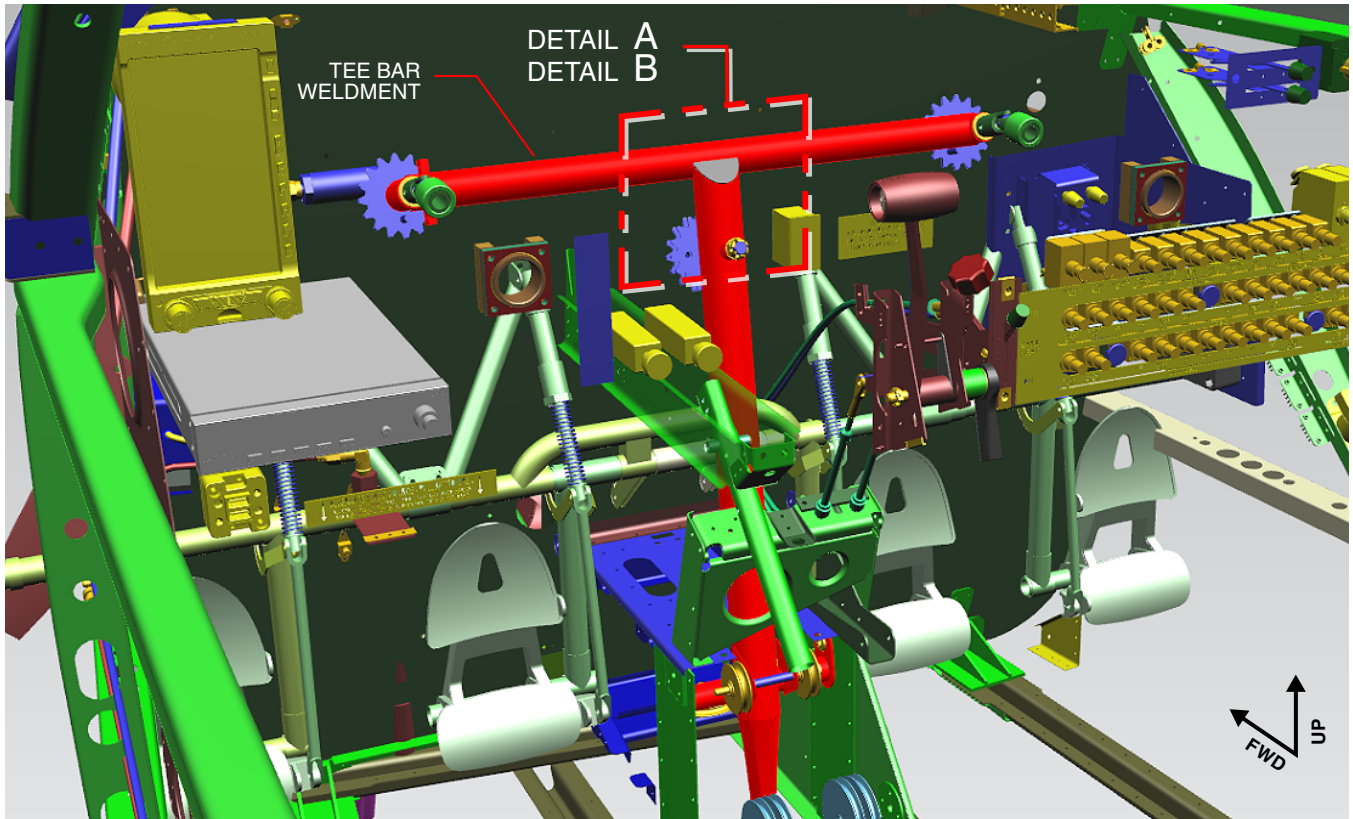
Figure 1
Tee Bar Assembly – Weldment

PURPOSE: A review of service history reveals that cracks may develop in the tee bar assembly of the affected aircraft. This service bulletin provides instructions for the recurring inspection of the tee bar assembly for cracks. Replacement of the installed tee bar weldment assembly with the applicable new tee bar weldment assembly specified in Table 1 will eliminate the need for a recurring inspection.

1. Gain visual access to the top center portion of the tee bar assembly, as shown in Figure 1. Identify the configuration of the tee bar weldment assembly.
 - If the local area conforms to Figure 1, Detail A, then recurring inspections are required. Proceed to Step 2.
 - If the local area conforms to Figure 1, Detail B, then the factory original tee bar assembly has already been replaced with a tee bar assembly containing the required features (i.e., gusset) and is already in compliance with Part II. Therefore, no recurring inspections are required. Proceed to Part II, Step 8.

2. Examine the area shown in Detail A for cracks, with special emphasis on welded joints.

DETAIL A
LOOKING FORWARD AT
CONTROL COLUMN TEE BAR WELDMENT
WITHOUT GUSSET

DETAIL B
LOOKING FORWARD AT
CONTROL COLUMN TEE BAR WELDMENT
WITH GUSSET

NOTE: Modification of the tee bar assembly as described in Part II, or installation of a replacement tee bar assembly with the features shown in Figure 1, Detail B, will relieve the recurring inspection requirement in Part I.

- b. Perform a fluorescent dye penetrant inspection per FAA Advisory Circular AC 43.13-1B, Chapter 5, Section 5.
 - If any cracks are discovered, then the tee bar weldment must be replaced prior to next flight. Proceed to Part II.
 - If no cracks are discovered, apply primer and topcoat to bare metal, per the applicable Piper Airplane Maintenance Manual (AMM) or Service Manual (SM) and FAA Advisory Circular AC 43.13-1B, Chapter 6. Proceed to Step 3.
