Piper Aircraft, Inc. 2926 Piper Drive Vero Beach, FL, U.S.A. 32960

SERVICE NO. 1355B BULLETIN

Date: August 18, 2022 (S)(M)

SUBJECT: TEE BAR ASSEMBLY INSPECTION

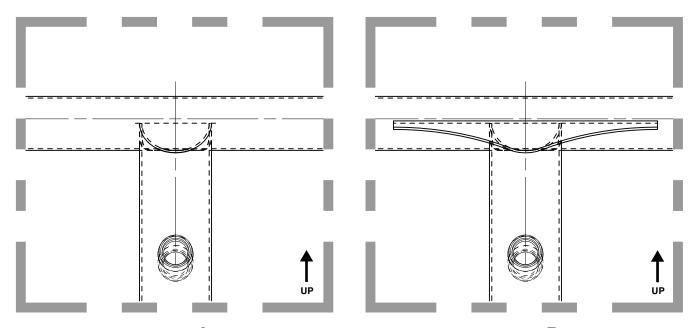
DETAIL A

- Examine the area shown in Detail A for cracks, with special emphasis on welded joints.
 - NOTE: For inspection and paint guidance, refer to FAA Advisory Circular AC 43.13-1B, "Acceptable Methods, Techniques, and Practices Aircraft Inspection and Repair." This free document is available for download from the FAA at https://www.faa.gov/regulations-policies/advisory-circulars/.

LOOKING FORWARD AT

CONTROL COLUMN TEE BAR WELDMENT

WITHOUT GUSSET

- If the local area conforms to Figure 1, Detail A, then recurring inspections are required. Proceed to Step 2.
 - If the local area conforms to Figure 1, Detail B, then the factory original tee bar assembly has already been
 replaced with a tee bar assembly containing the required features (i.e., gusset) and is already in compliance
 with Part II. Therefore, no recurring inspections are required. Proceed to Part II, Step 8.

- a. If the paint is cracked, chipped or peeled in the vicinity of the inspection areas, or if there is evidence of corrosion (such as staining or blistering), then a fluorescent penetrant inspection is required as described in Step b, below. Prepare the surface by removing the paint using Cee-Bee A-202 paint stripper, or an equivalent. Wipe off any residue, in the areas where the paint was removed, with isopropyl alcohol.

- b. Perform a fluorescent dye penetrant inspection per FAA Advisory Circular AC 43.13-1B, Chapter 5, Section 5.
 - If any cracks are discovered, then the tee bar weldment must be replaced prior to next flight. Proceed to Part II.

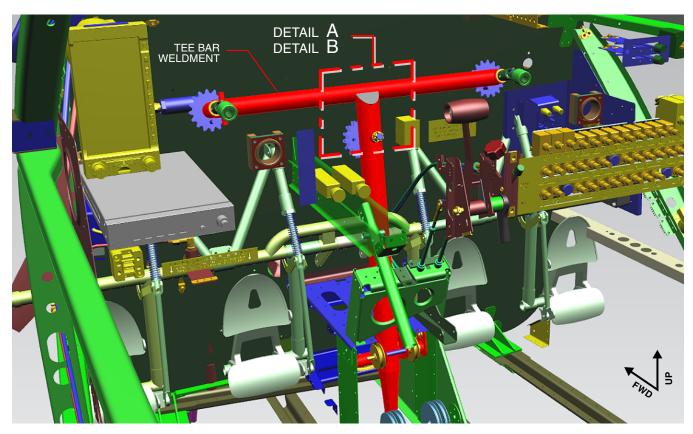
Figure 1
Tee Bar Assembly – Weldment

- Gain visual access to the top center portion of the tee bar assembly, as shown in Figure 1. Identify the configuration of the tee bar weldment assembly.

DETAIL B

LOOKING FORWARD AT

CONTROL COLUMN TEE BAR WELDMENT

WITH GUSSET

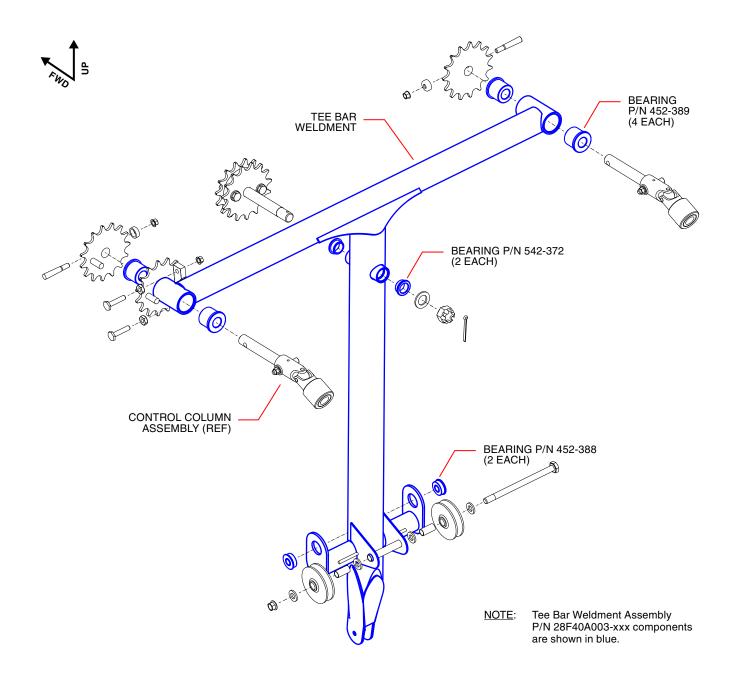
Figure 2

Tee Bar Assembly – Weldment Assembly Installation

- 4. Assemble the control wheel tee bar assembly (refer to Figure 2): Install the sprockets, control wheel columns, and hardware, which were removed from the original weldment assembly in the previous step, onto the replacement tee bar weldment assembly.

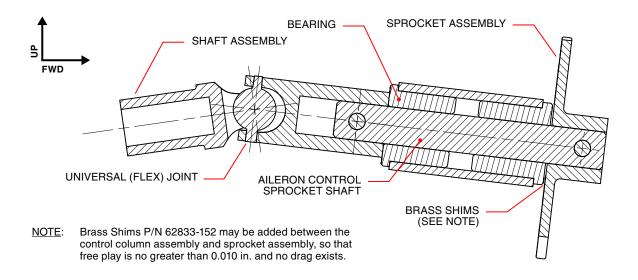
Figure 3
Brass Shim P/N 62833-152 Installation Location

CONTROL COLUMN ASSEMBLY - TYPICAL

LOOKING OUTBOARD PILOT SIDE SHOWN (COPILOT SIDE SIMILAR)

- 5. Reinstall the control column tee bar assembly and control wheel columns, in accordance with Section 27-10-00 of the applicable Piper AMM or Section V of the applicable SM. If necessary, so that there is no greater than 0.010 in. of free play (relative motion) and no drag exists between the control columns and sprocket assemblies, add Brass Shims, Piper P/N 62833-152, no more than two (2) per side, as shown in Figure 3.
