SERVICE NO. 1399 BULLETIN

PIPER CONSIDERS COMPLIANCE MANDATORY

Date: March 16, 2023

WING RIB MODIFICATION

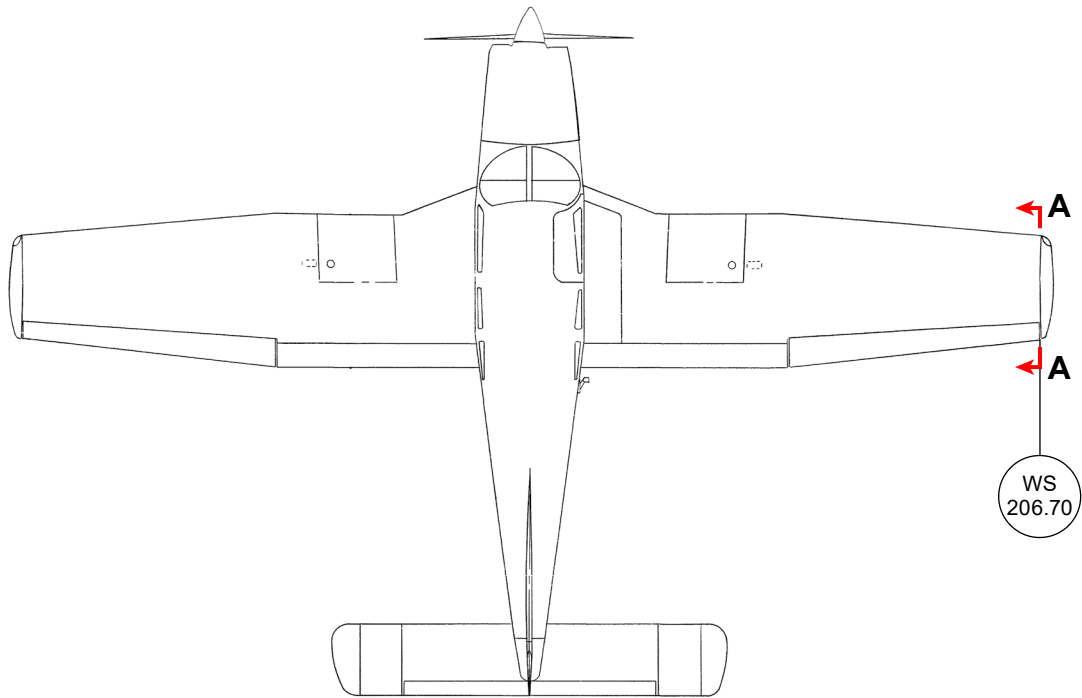
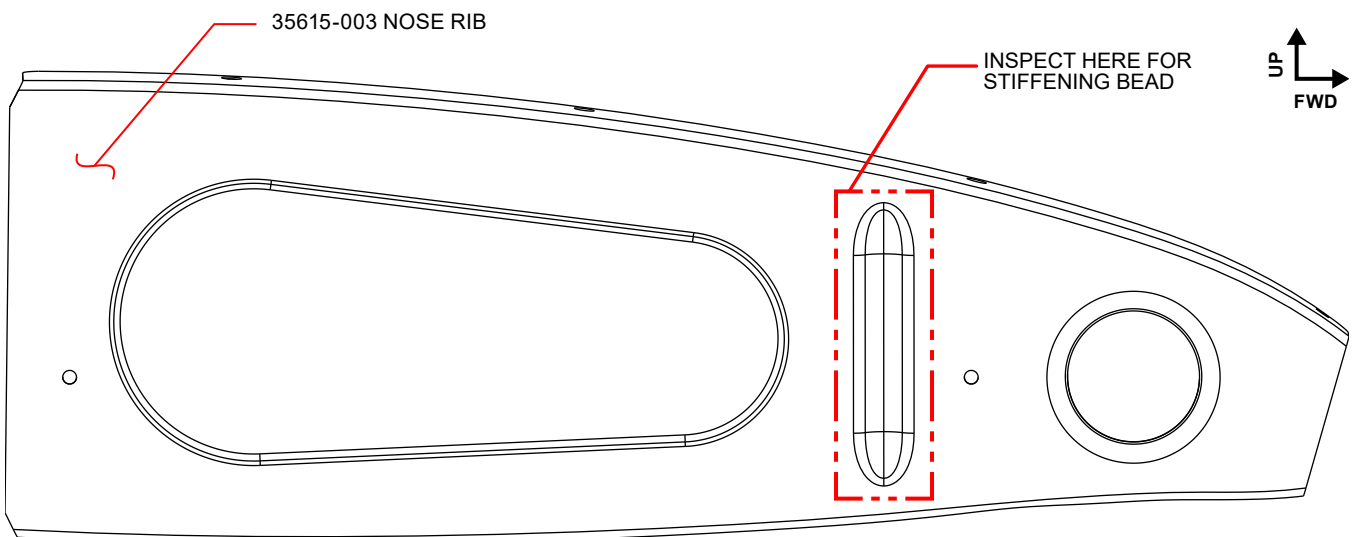
Figure 1
Nose Rib Inspection

PURPOSE: Some of the affected aircraft may have a Wing Station (WS) 206.70 Nose Rib that does not conform to type design, applicable to the right wing only. These ribs may not provide adequate structural stability to maintain the local wing contour for the outboard bay.

2. Gain visual access to the right wing WS 206.70 Nose Rib, Piper P/N 35615-003, as shown in Figure 1.
3. Examine the Nose Rib for the presence of a stiffening bead at the location identified in View A-A.

- If the WS 206.70 Nose Rib has the stiffening bead feature, no modification is required. Proceed to step 6.
 - If the WS 206.70 Nose Rib does not have the stiffening bead feature, modification of the Nose Rib is required. Proceed to step 4.
