SERVICE LETTER

Flap Warning Placard

Piper Aircraft Corporation

Lock Haven, Pennsylvania, U.S.A. January 6, 1977 S/M

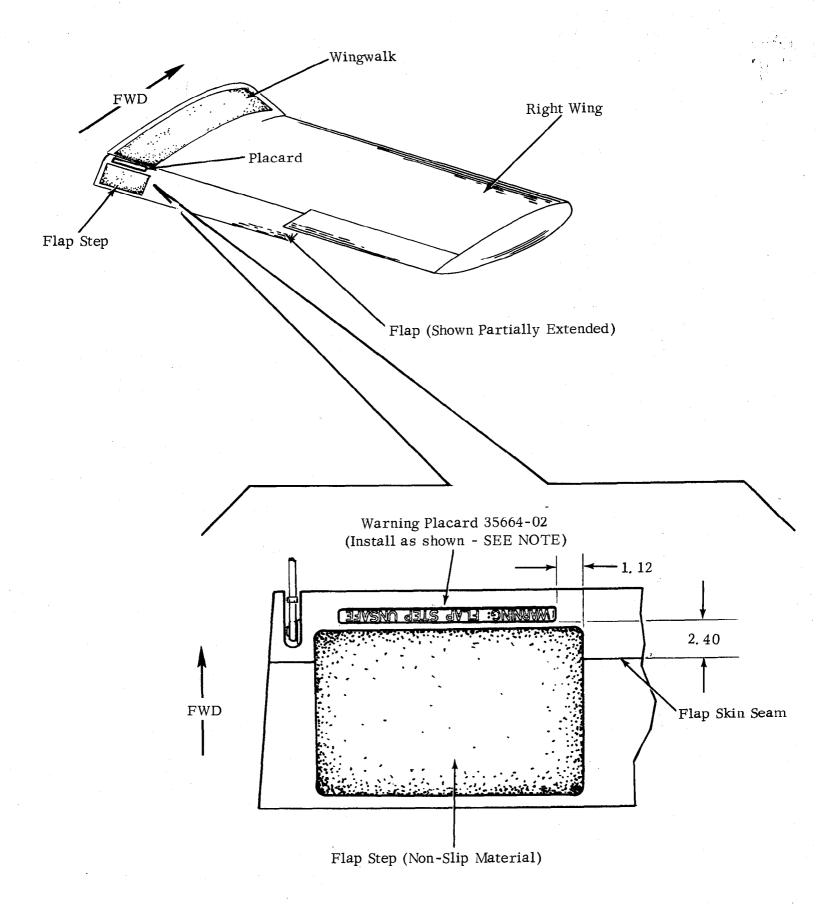
Purpose: Reports from the field indicate the need of a placard that will warn persons boarding or deplaning any of the above affected aircraft of the flaps being partially extended or unlocked.

Instructions: Apply placard per attached instructions data.

NOTE: If required, it is permissible to trim forward edge of flap step material in order to install the placard at the dimensions shown. Seal trimmed edge with 3M Edge Sealing Compound #62-5569-2660-8 (5 oz. Tube - Piper P/N 914 055).
