SERVICE LETTER

No. 836

Piper Aircraft Corporation

Subject: Narco ADF 140/141 Antenna Inspection and Modification

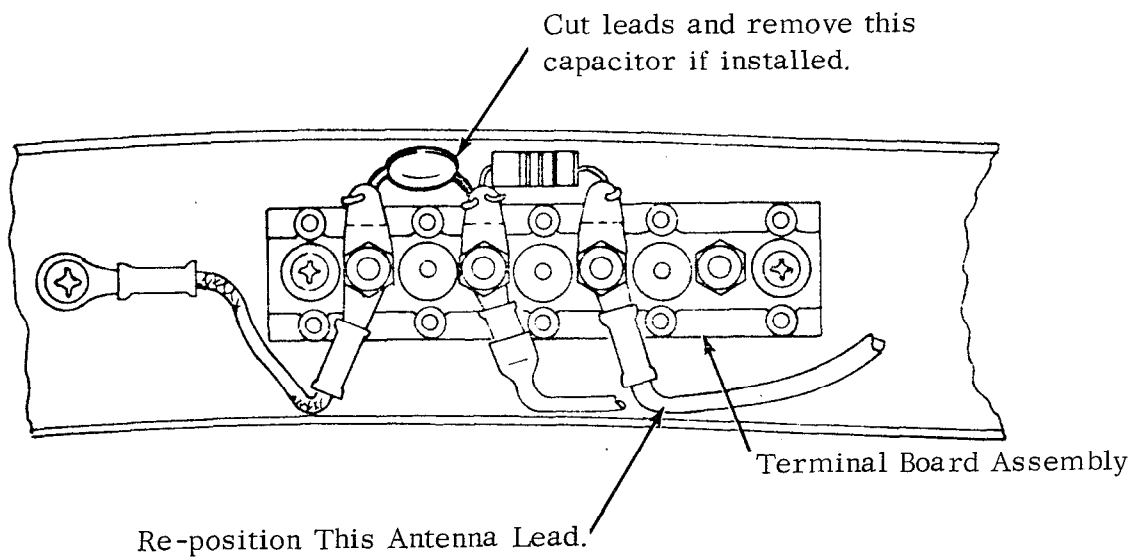
FIGURE 1 - Terminal Board Prior to Modification

1. Insure the aircraft is equipped with a Narco ADF-140/141 receiver.
2. Remove top overhead speaker panel to gain access to the terminal block connections from the sense antenna lead in.
3. Inspect antenna terminal board for position of antenna lead attachment and presence of capacitor (if installed); referenced attached sketch fig. 1.
