# SERVICE NO. 1218 LETTER

Date: July 13, 2017

**CREW SEAT CONTROL CABLE MODIFICATION**

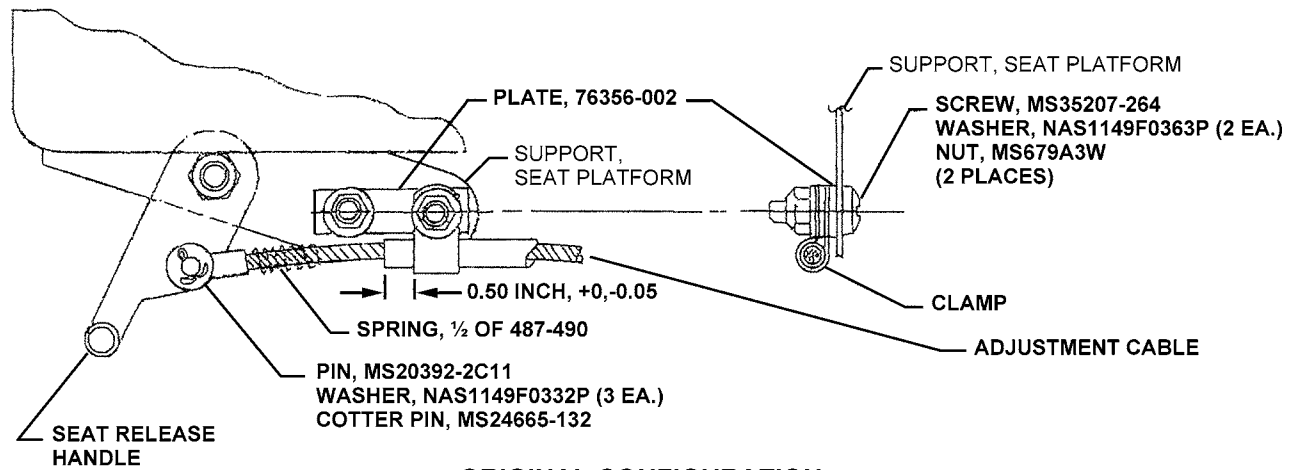
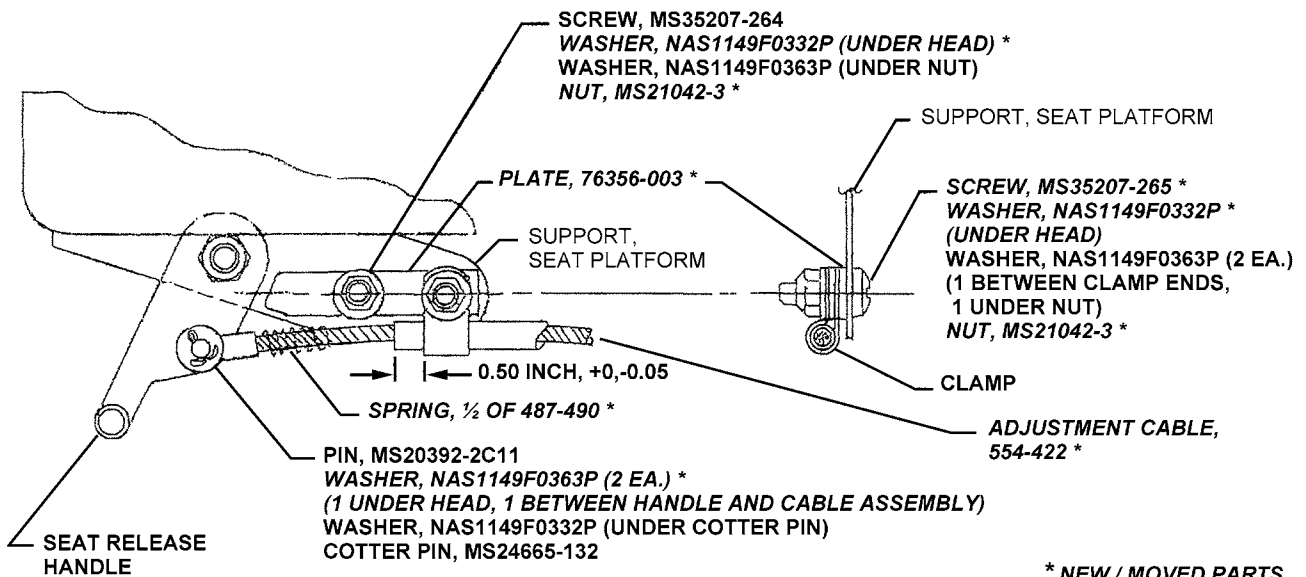
VIEW A-A

- 1) Cut the new spring (Piper P/N 487-490) in half.
    - 2) Install a half of the spring onto the upper end of the new adjustment cable: Rotate the cut end of the half spring onto the cable, and continue to rotate the half spring until it is on the cable as shown in View A–A.

- 7) At the upper right side of the seat base assembly, capture the cable with the P-clamps and loosely install the new plate (P/N 76356-003) and P-clamps to the seat platform support with screws, washers, and nuts.

- 8) Position the cable housing end as shown in View A–A and secure in place by tightening nuts evenly at the P-clamps.
    - 9) Connect the cable to the seat release handle by installing the pin, washers, and cotter pin.
