Piper Aircraft, Inc.
 2926 Piper Drive
 Vero Beach, FL, U.S.A. 32960

SERVICE NO. 1218A LETTER

Date: August 8, 2017

CREW SEAT CONTROL CABLE MODIFICATION

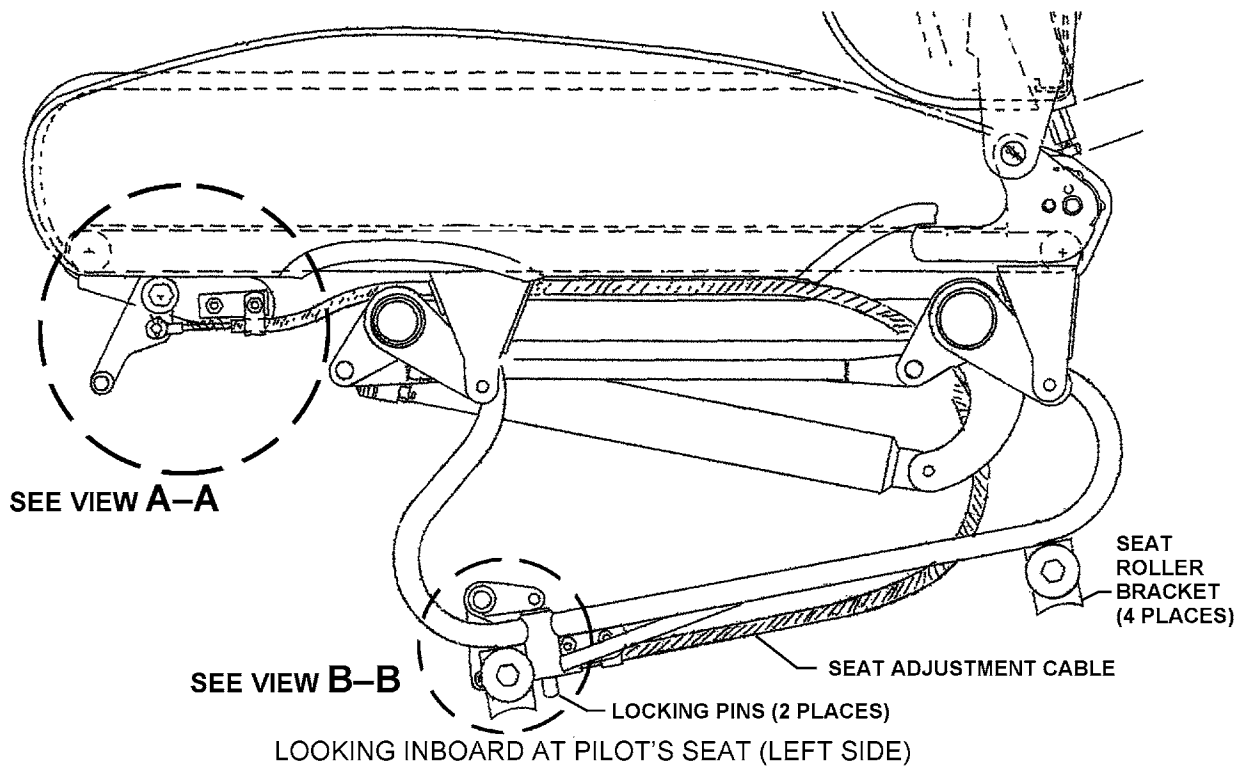
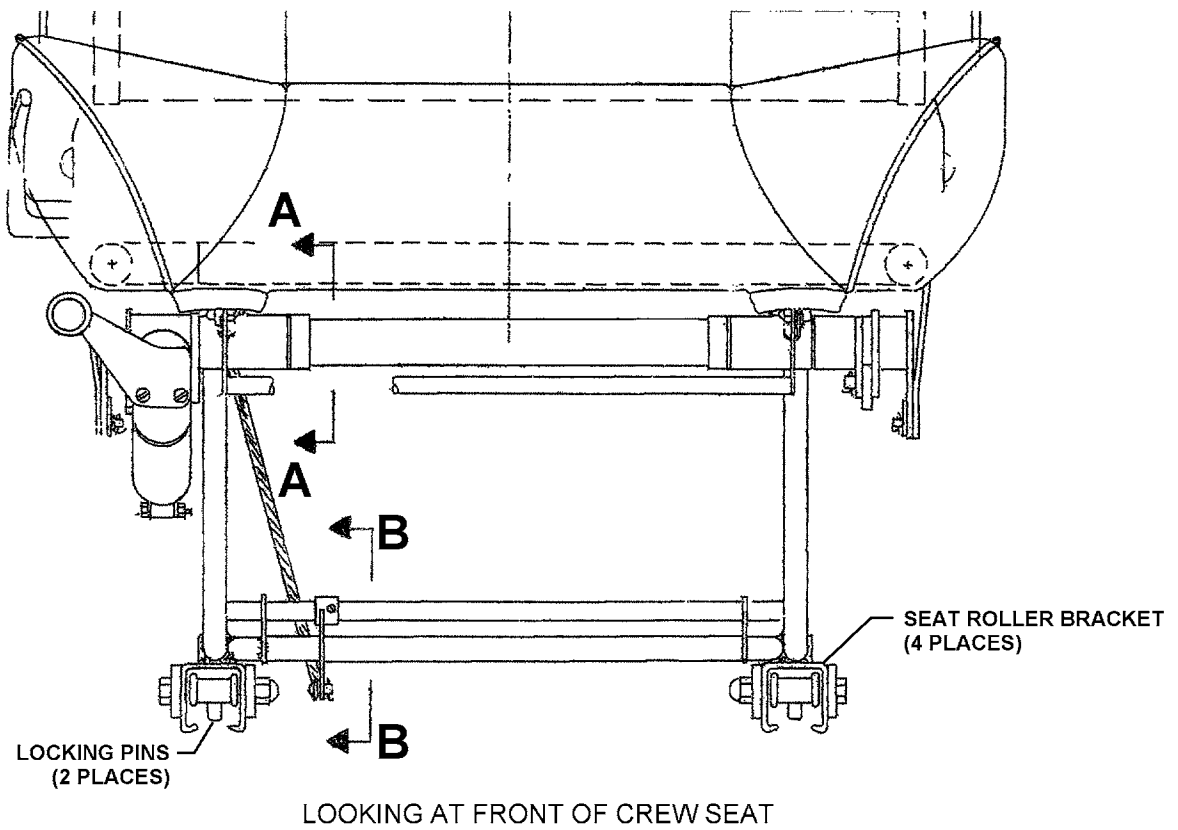
Figure 1, Sheet 1 of 2
Crew Seat Adjustment Cable Installation

1. The modification consists of replacing the existing seat platform support plate (P/N 76356-002) with a longer version (P/N 76356-003) which limits aft travel of the seat release handle assembly. If the seat release handle assembly is allowed to freely travel aft it can cause the adjustment cable to kink which contributes to unnecessary wear on the cable and shortened service life. Some of the associated hardware is also replaced.
2. The following steps address replacing the cable in one seat (refer to Figure 1):
 - a. Remove and discard the old adjustment cable.
 - b. Install the new adjustment cable as follows:
 - 1) Cut the new spring (Piper P/N 487-490) in half.
 - 2) Install a half of the spring onto the upper end of the new adjustment cable: Rotate the cut end of the half spring onto the cable, and continue to rotate the half spring until it is on the cable as shown in View A–A.

- 3) Route the cable as shown in Figure 1. Take care to ensure the upper and lower ends are correctly positioned.
 - 4) At the bottom right side of the seat base assembly, capture the cable with the P-clamps and loosely install the P-clamps to the seat bottom base assembly with screws, washers, and nuts.
