## VENDOR SERVICE PUBLICATION

**SUBJECT:** CONTINENTAL MOTORS CRITICAL SERVICE BULLETIN CSB19-01,  
'FUEL (PRIMER) DIVERTER VALVE ASSEMBLY'

**CONTINENTAL MOTORS® AIRCRAFT ENGINE  
CRITICAL SERVICE BULLETIN**

**CATEGORY 2  
CSB19-01**

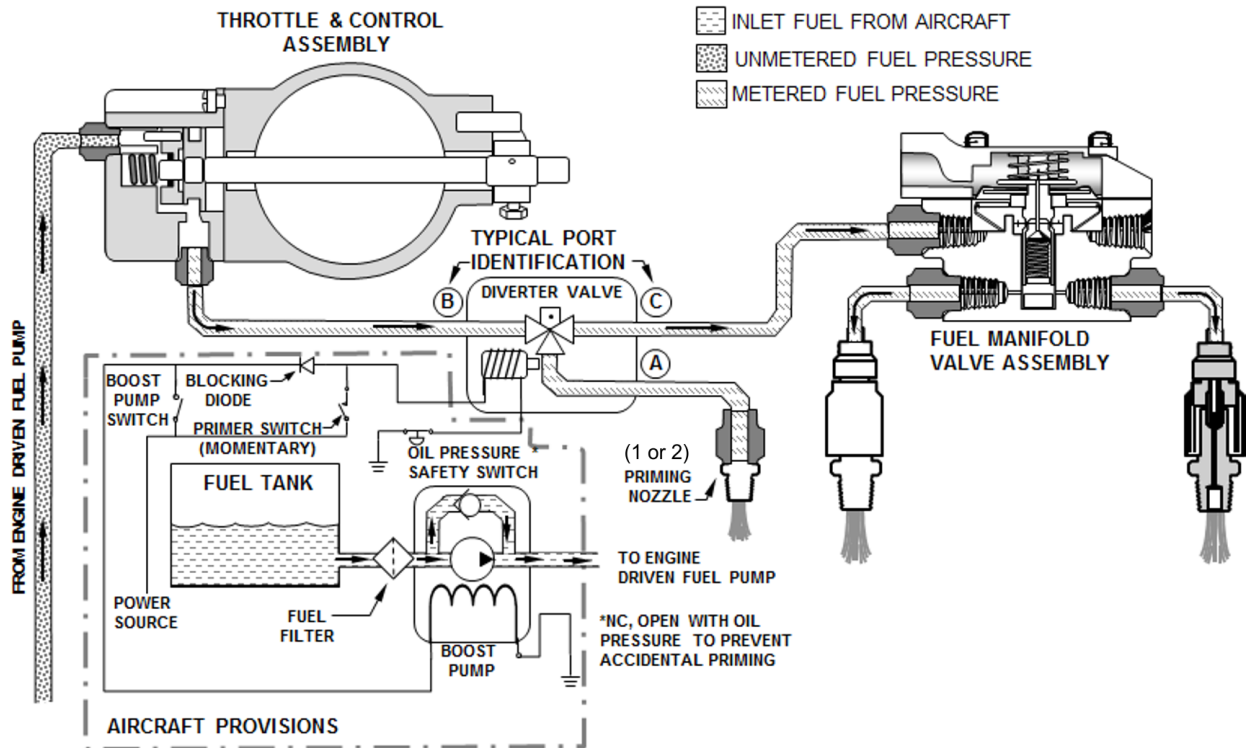
Figure 1. Fuel Diverter Valve Assembly, typical

Continental Motors has received reports of fuel (primer) diverter valve malfunction that can result in a partial or complete loss of power.

1. Verify your cross-flow engine has a fuel diverter valve assembly (P/N 633862-1, 642199-1, (14V), or 633862-2, 649268-2 (28V), as shown in Figure 1).

2. Remove the fuel diverter valve assembly from service according to the latest revision of the applicable Maintenance and Overhaul Manual, Section 12 (engines as listed in the “Models Affected”).

- a. Remove fuel diverter valve assembly (tubes and connectors) between the throttle and control assembly and fuel manifold valve assembly (see Figure 1, port identification B & C and Figure 2 through Figure 4, example configurations).
- b. Remove tube/hose assembly, as applicable, (see Figure 1, port identification A and Figure 2) between fuel diverter valve assembly and priming nozzle(s).
- c. Remove disconnected priming nozzle connector(s) and tube assemblies connected to induction system (location references see Figure 2 and Figure 7).

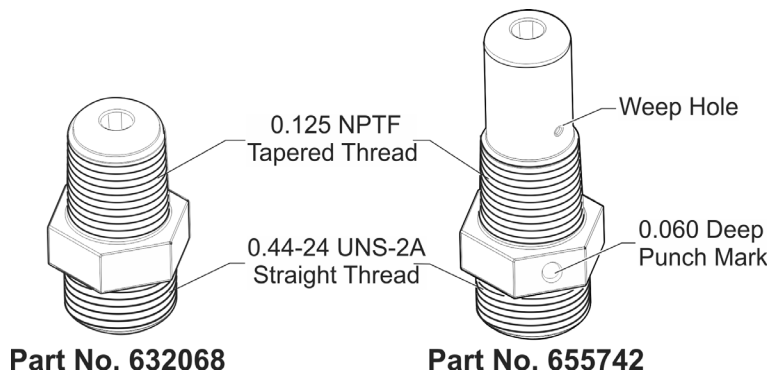
**Figure 5. Cylinder Drain Connector, P/N 632068 superseded by 655742**

The cylinder drain connector serves the same priming function as the primer diverter valve and allows the removal of the fuel diverter valve assembly from current production model specifications. Inspect for the current production cylinder drain connector (P/N 655742). The cylinder drain can be identified by a 0.060 deep punch mark in the wrenching flat (see Figure 5, P/N 655742).

1. If the cylinder drain is identified as P/N 655742, replacement is not necessary.
2. If the cylinder drain cannot be identified, perform an “Induction System Drain Inspection” according to M-0, Standard Practice Maintenance Manual, Section 6. If applicable, remove and replace cylinder drain connector(s) with current P/N 655742 (quantity based on number of engine cylinders).
